Subject: FW: QN - 16 February - Roaster incident update
Attachments: 2016 02 16 330-1401 Roaster 1 EVD Explosion Post Incident External Damag....pdf

POST-INCIDENT EXTERNAL DAMAGE SURVEY

Equipment No:	330-1401 Roaster 1	Cintellate:	INC-36529
Inspected By:		Inspection Date:	16/02/2016

MAJOR HAZARD FACILITIES AUDIT REPORT

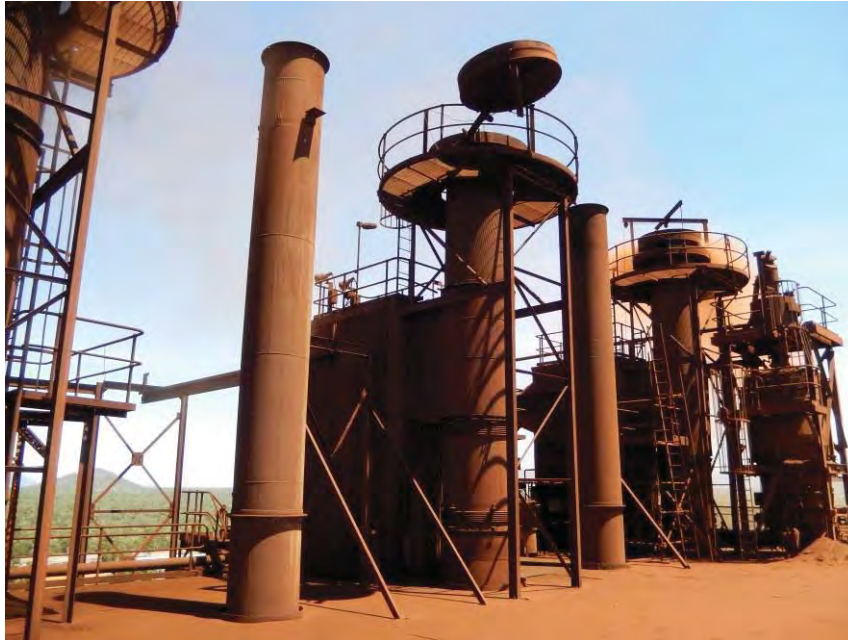
Item #	1
Asset	330-1401-EVD Roaster 1 Emergency Vent Damper Assembly
Location	E.V.D Dust Seal Cap (Lid) and Frame
Finding

E.V.D lid no longer secured to framework and was now resting in North-West (plant) direction on the handrail

Access is required for closer inspection.

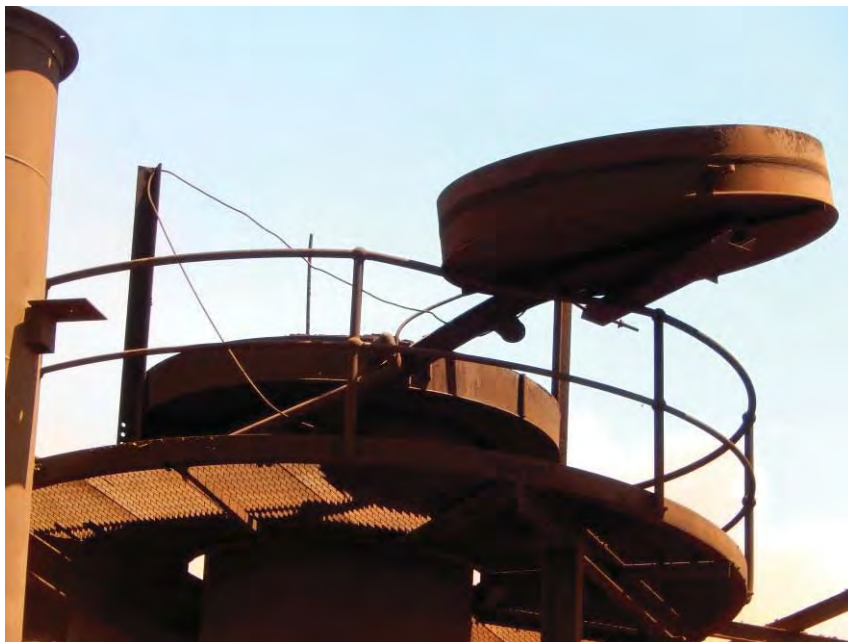
Handrail deformed under load of E.V.D lid.

E.V.D lid frame structure destroyed and has jammed lid in observed position.

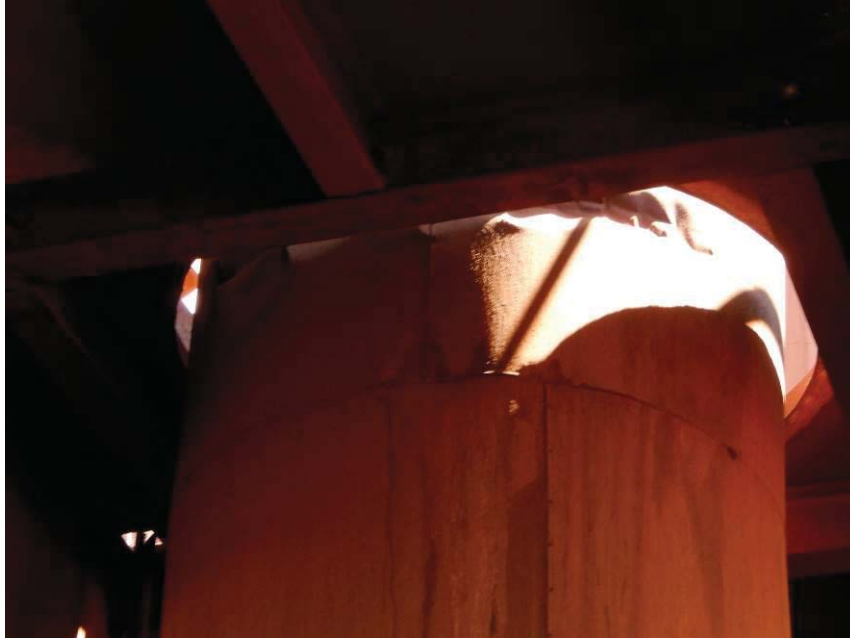
Item #	2
Asset	330-1401-EVD Roaster 1 Emergency Vent Damper Assembly
Location	Roaster 1 to E.V.D Vertical Duct
Finding

Crimping of lagging due to impact was evident on northern half, East to West.

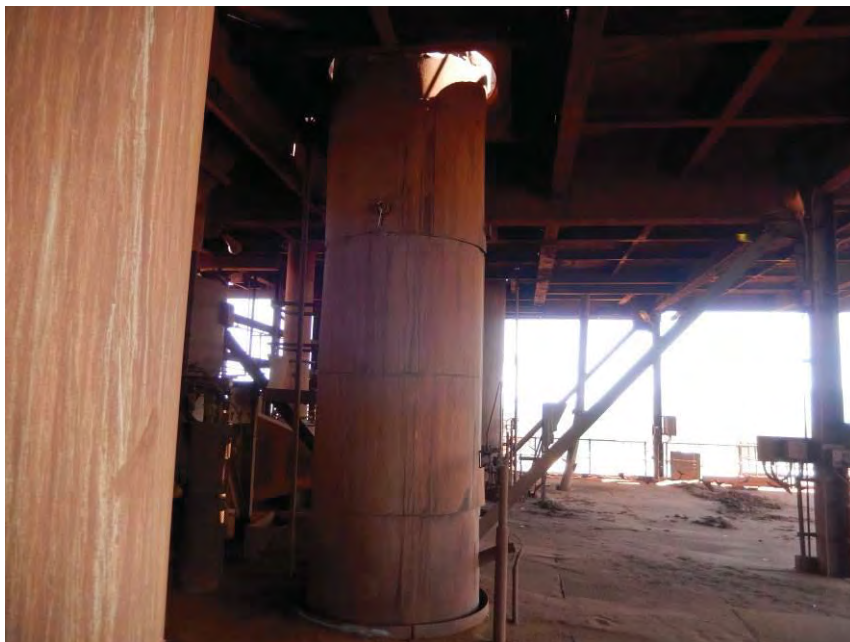
Lagging was loose in locations suggesting movement of chute.

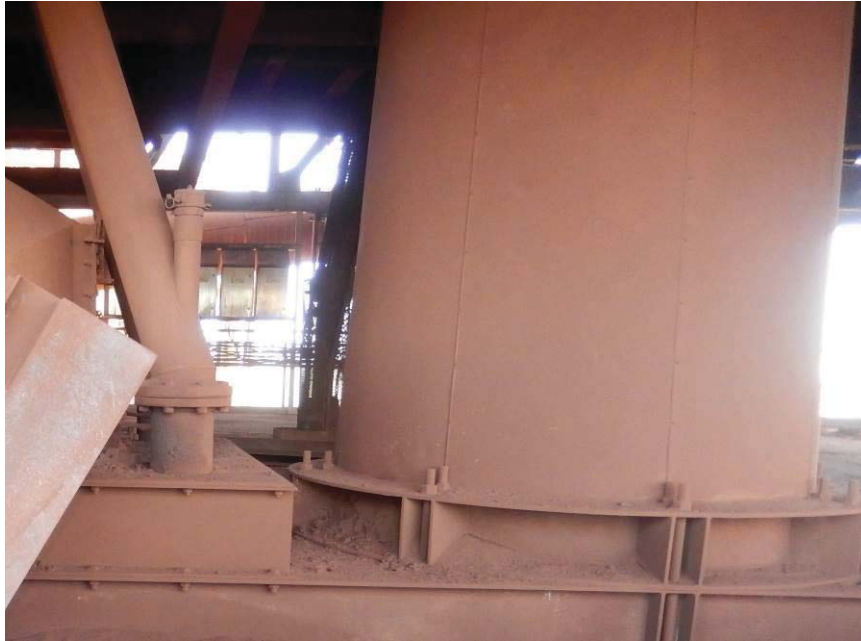
Item #	3
Asset	330-1401-EVD Roaster 1 Emergency Vent Damper Assembly
Location	Roaster 1 to E.V.D Vertical Duct connection
Finding

No gross damage evident.

Recommend clean and closer inspection to confirm and identify minor effects.

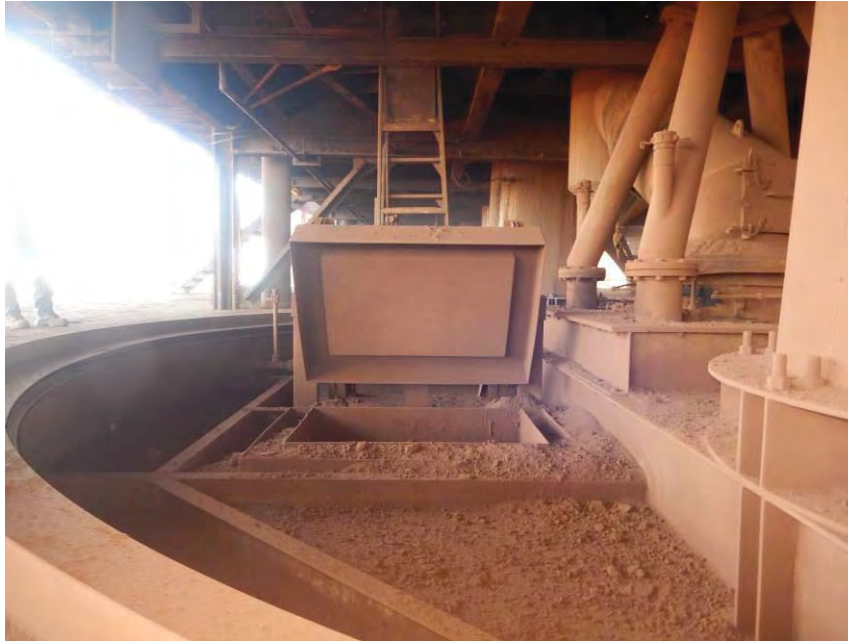
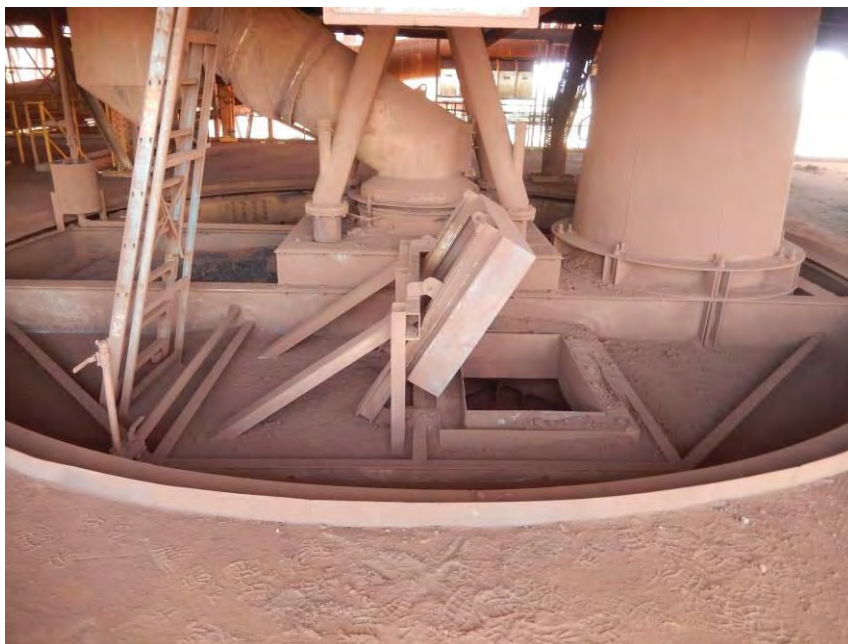
Item #	4
Asset	330-1401 Roaster 1
Location	Roaster Roof and Beams
Finding

Beams did not exhibit deformation as observed by visual inspection.

Debris accumulation prevented close assessment. Removal of debris is required to allow further inspection.

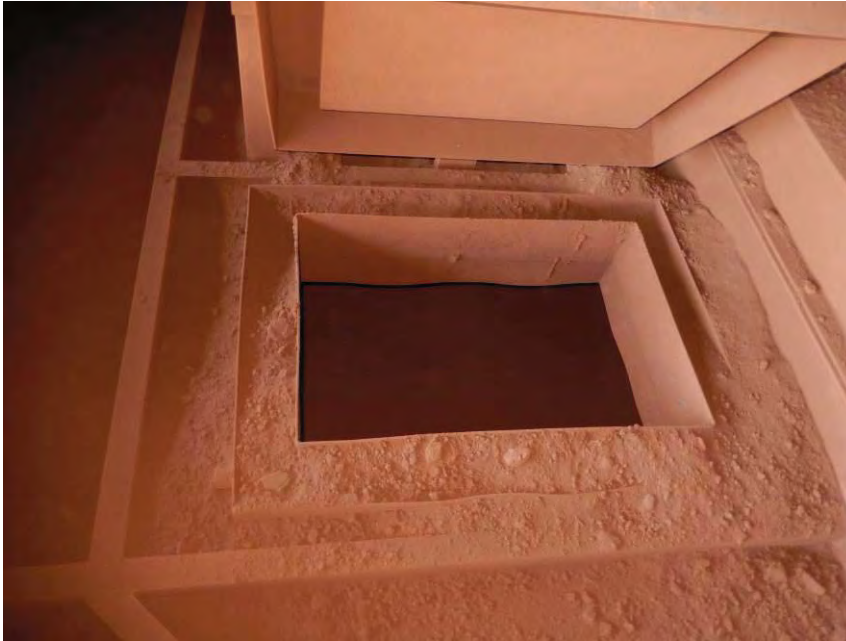
Item #	5
Asset	330-1401 Roaster 1; 330-PSE1401 Roaster 1 Explosion Door
Location	Roaster Top Hatch
Finding

Deformation of "seal" and debris accumulation. Limited reduction in integrity would be expected from this deformation.

Note: Ore is use to seal around the explosion door during operation

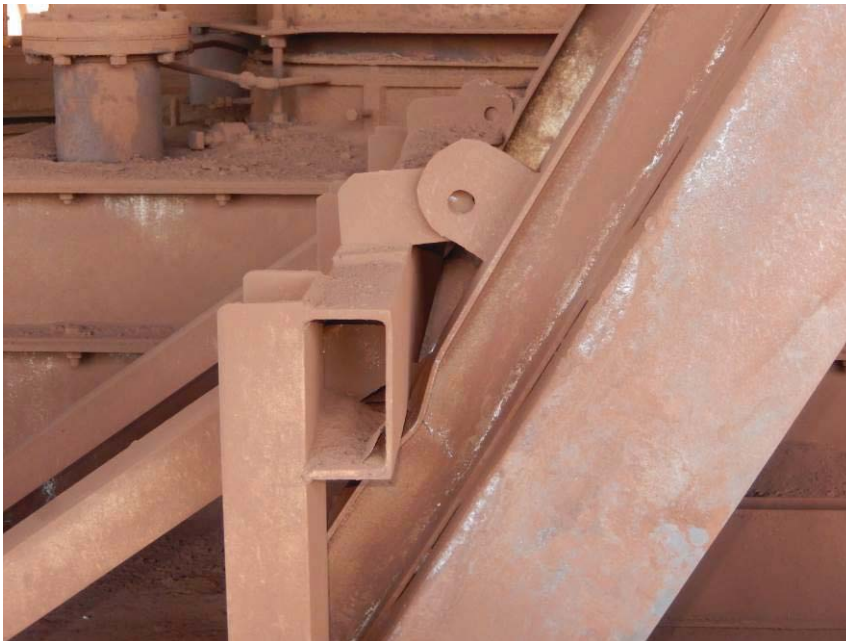
Explosion door latching beams deformed locally at impact points. Limited reduction in integrity would be expected from this deformation.

Framework for explosion door did not display obvious signs of damage, however attachment points to roaster roof should be cleaned free of debris to allow assessment.

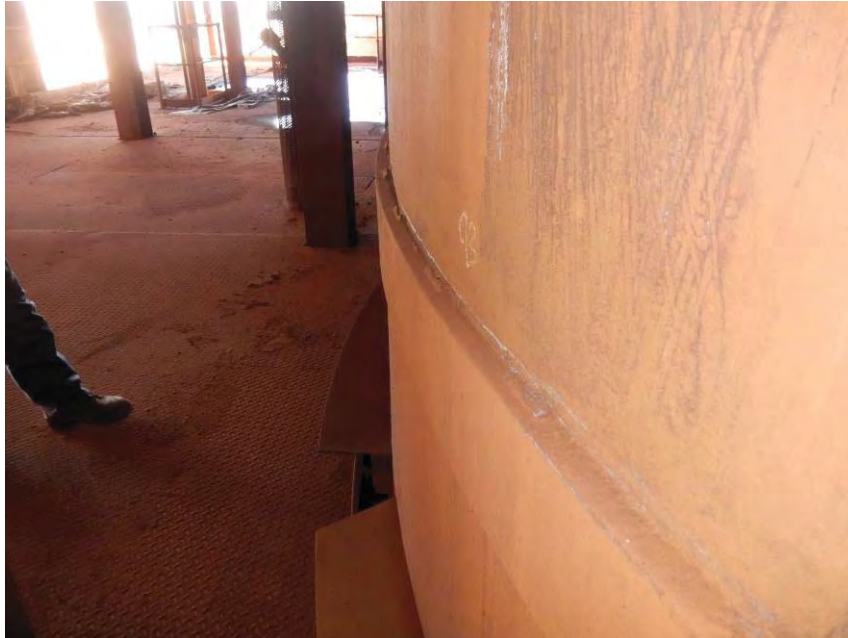
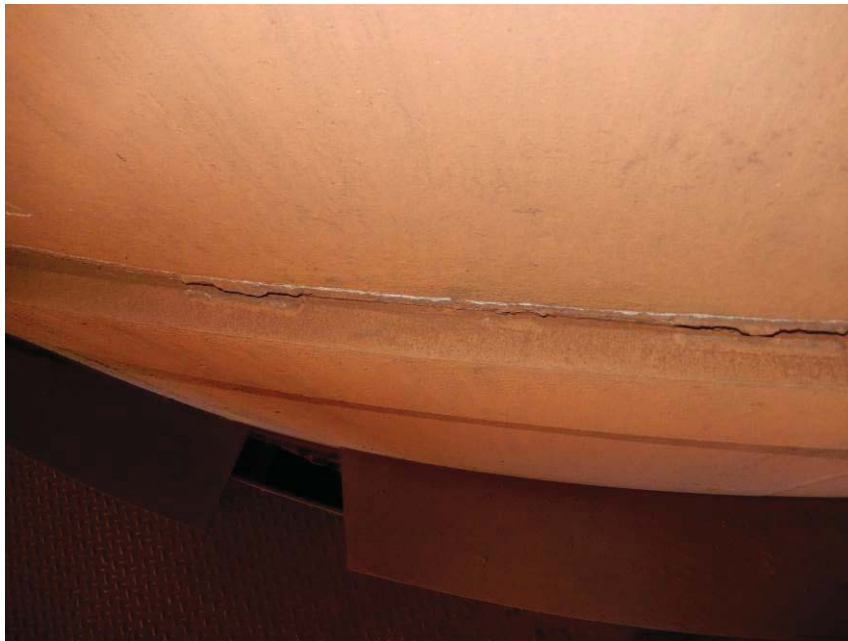
Item #	6
Asset	330-1401 Roaster 1
Location	Level 8 East side
Finding

Pre-existing crack in welds at skew band, approximately 4000mm long.

Crack may have been exacerbated by event; however this cannot be verified without further data.

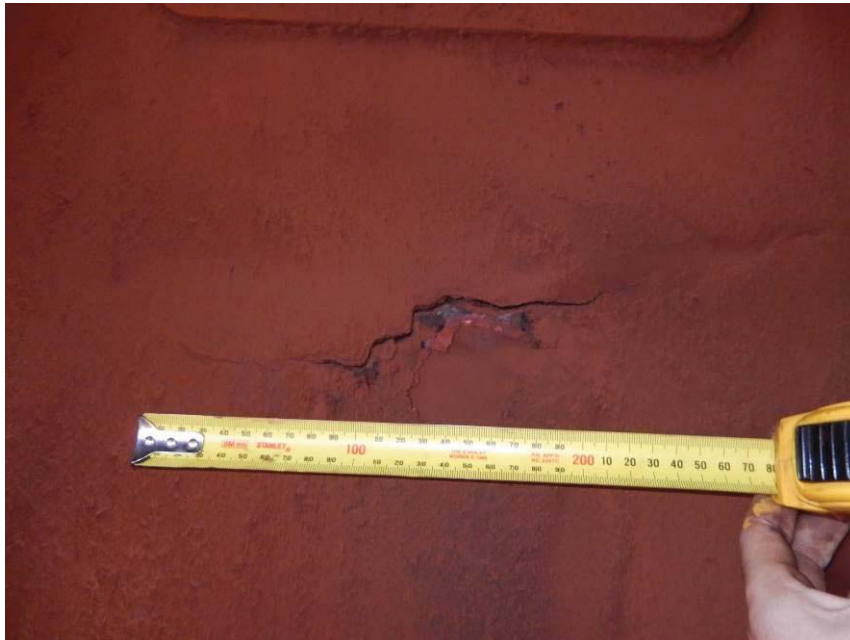
Item #	7
Asset	330-1401 Roaster 1
Location	Level 5 West (Hearth 9)
Finding

Crack 250mm long near informed point of ignition.

Crack displayed signs of pre-event existence (typical signs of internal corrosion), however indications of exacerbation was evident.

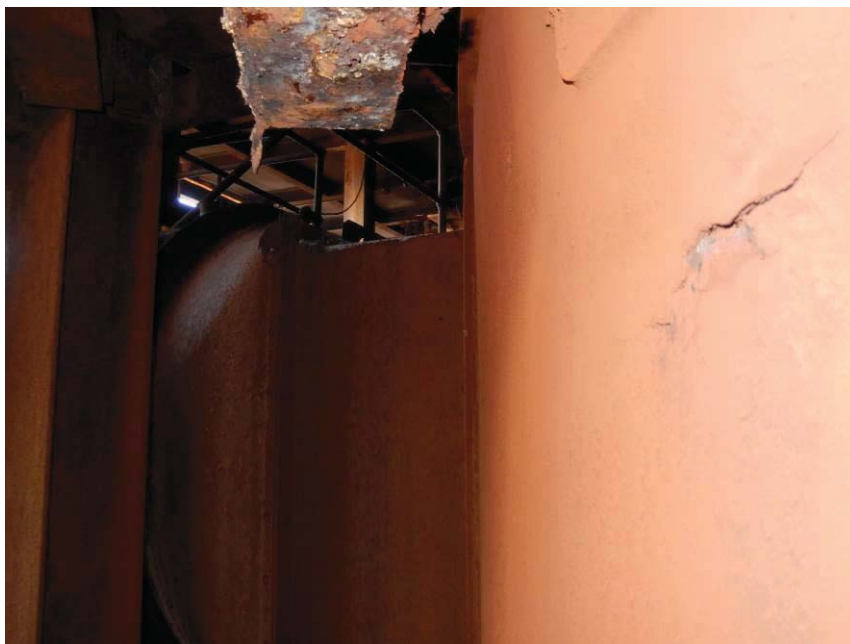
Plate has been deformed over an approximate 4 sq. m area.

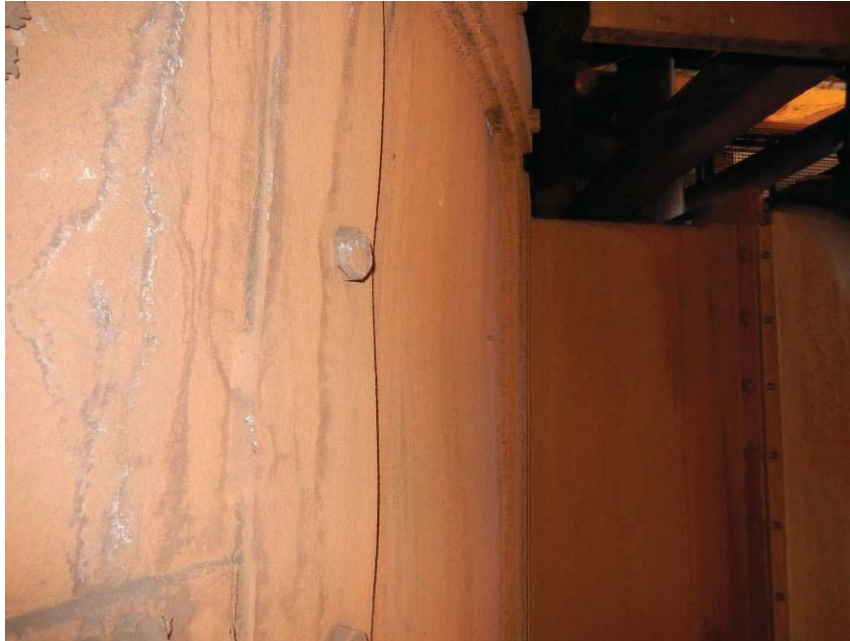
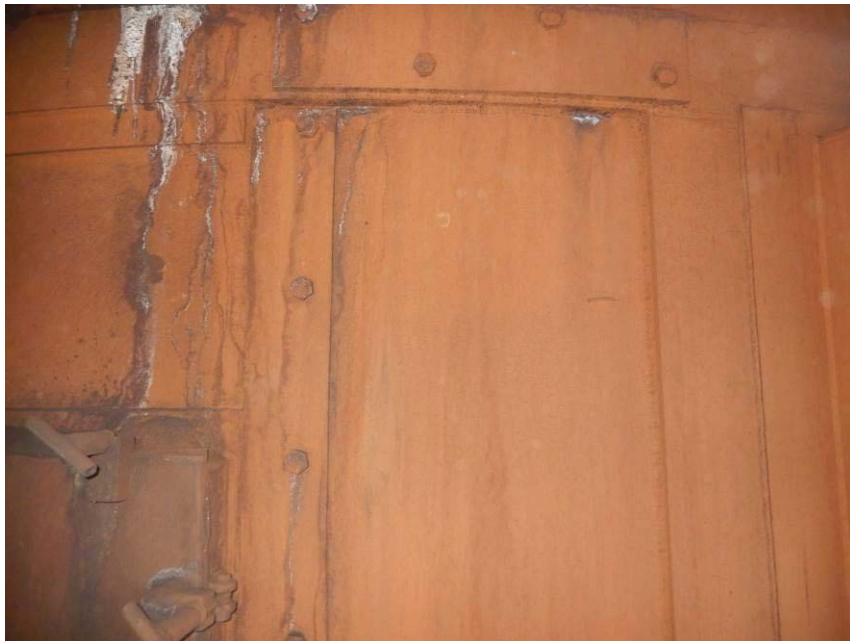
Item #	8
Asset	330-1401 Roaster 1
Location	Level 2 West
Finding

Plate section approximately 1.5 sp. m area was deformed. Unable to confirm whether induced or exacerbated.

Location is near typical hot spot of roaster and looks to be adequately braced.

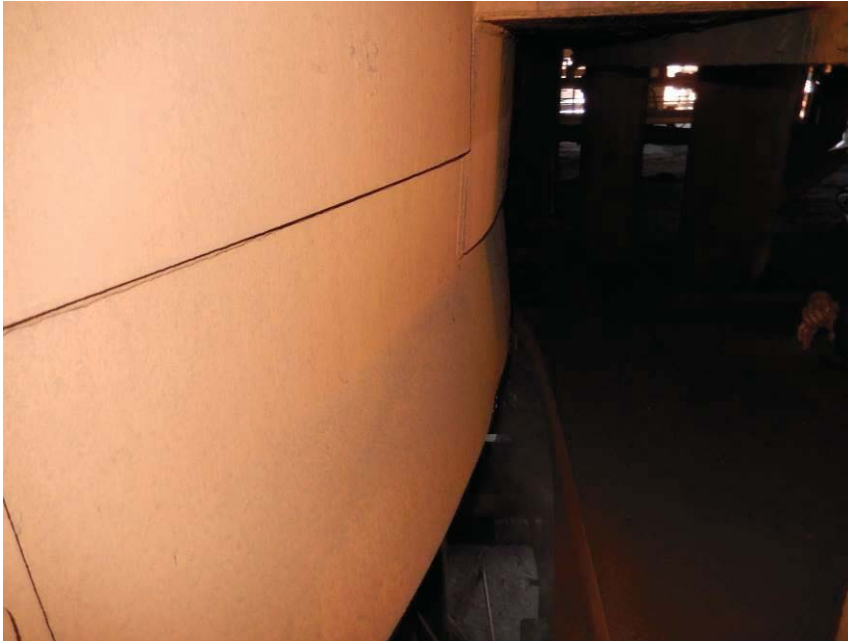
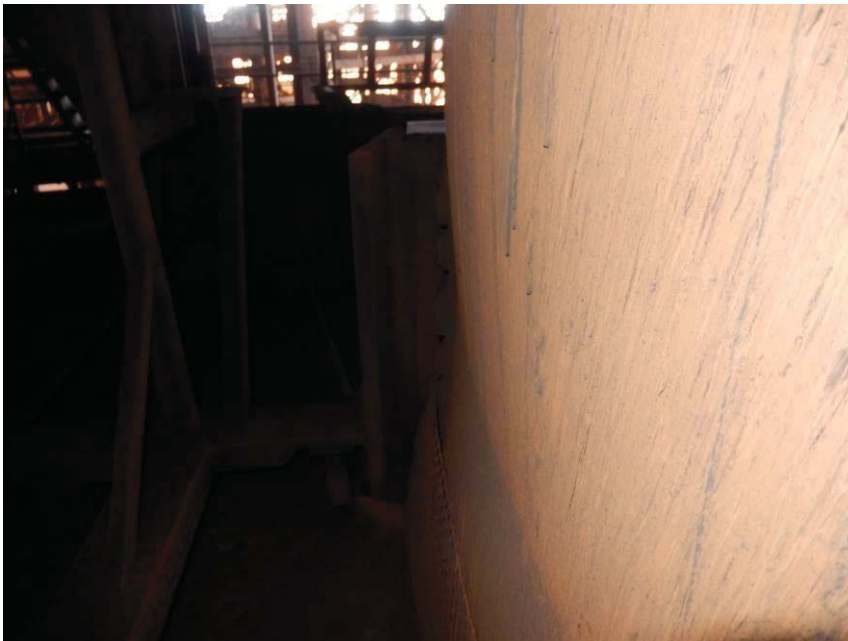
Item #	9
Asset	330-1401 Roaster 1
Location	Level 1 Flare
Finding

Circumferential "Flare" of roaster base.

Flare is non consistent with nature of incident.

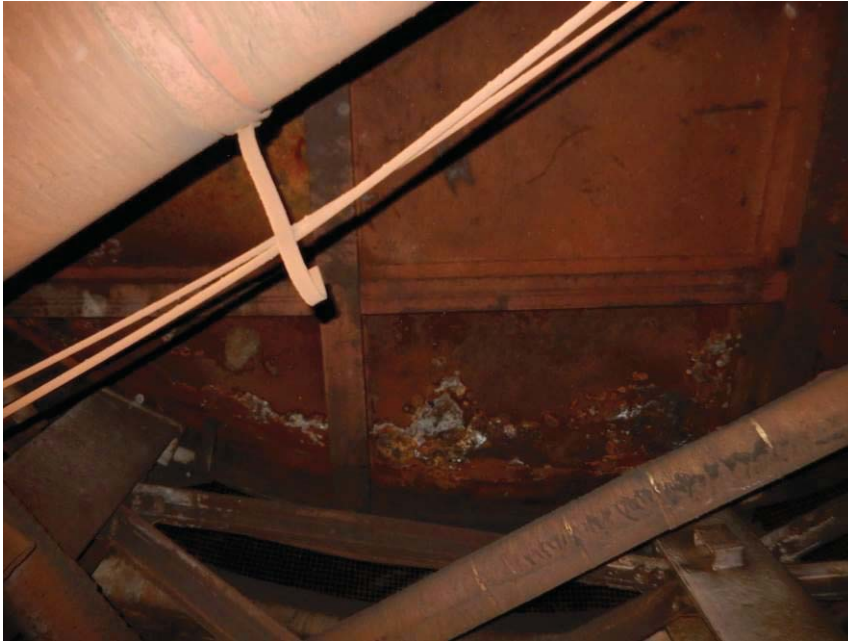
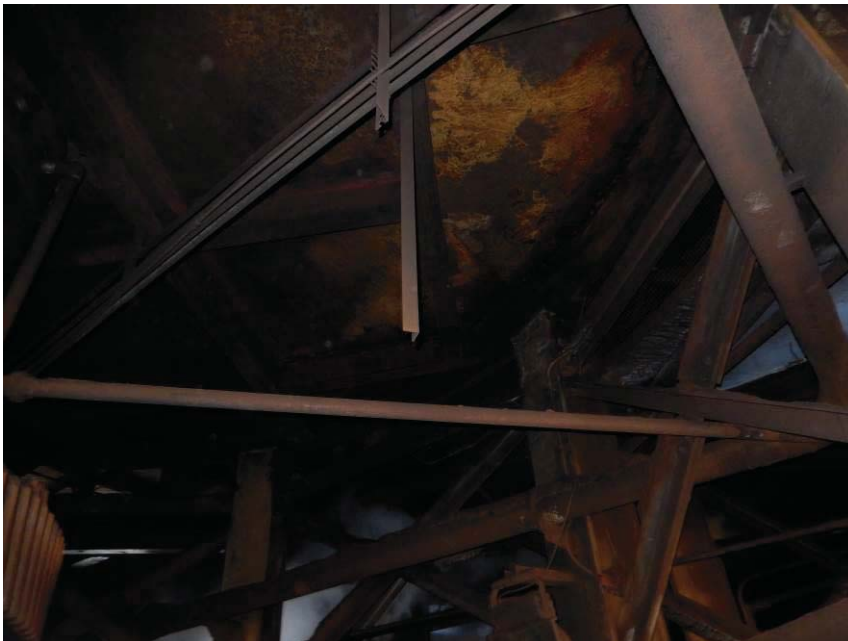
Item #	10
Asset	330-1401 Roaster 1
Location	Roaster Floor
Finding

Roaster floor was obviously convexly bowed, particularly in the corroded locations on the southern side.

To what degree (if any) the increase in bow was due to the incident is indeterminate.

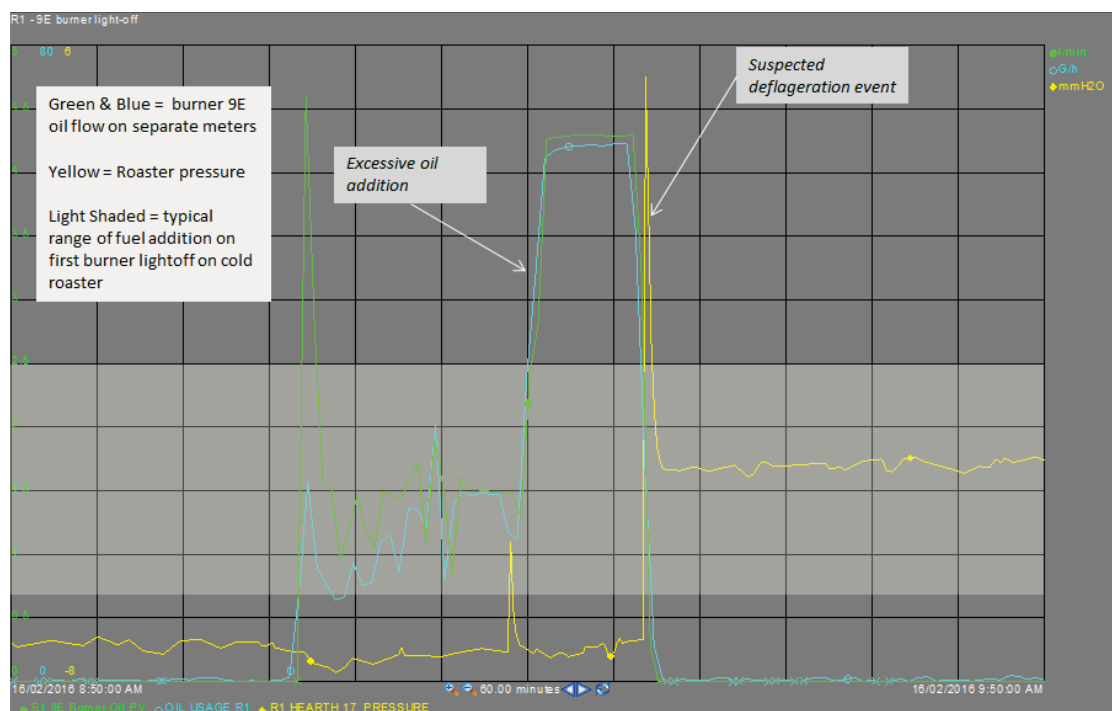
10. QNI have looked at process trends following this incident, and have found that there was unexplained increase in oil flow to the burner in hearth 9 for a period of 5-6 minutes prior to the explosion occurring. A copy of the trend is provided below.

11. A pressure transmitter located inside the Roaster detected the moment the explosion occurred.
12. The reason for the increase in oil flow to the burner is not yet known. Possible explanations include operator error and burner malfunction, including the possibility that the burner had a blockage in the oil line which then cleared itself.
13. Based on trend data it appears that an additional 20L of oil was added to the Roaster from between where the excessive oil addition started and the explosion event.

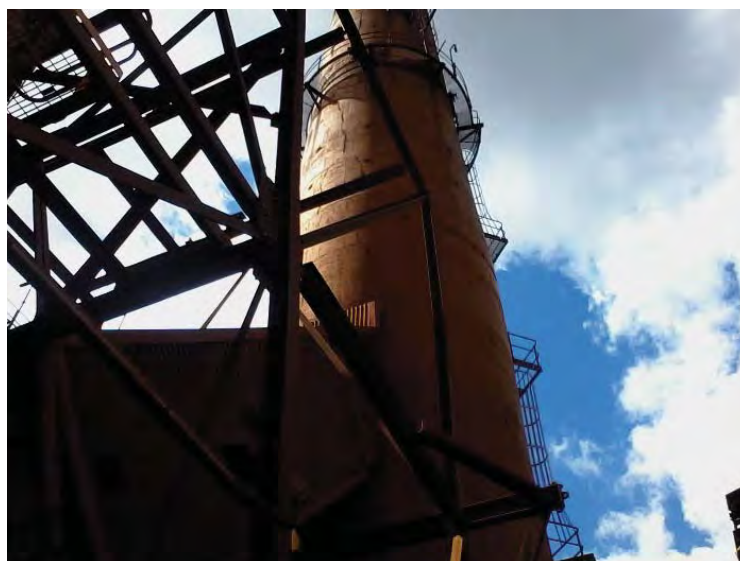
From outside the exclusion zone, the inspector sighted numerous vertical cracks around the outer shell of the stack. The size of these cracks varied, with some cracks ranging up to an estimated 20-30m in length (Figure 1). A small pile of bricks were observed at the base of the stack at an inspection door (Figure 2). It was reported that those bricks were from the internals and were removed to facilitate the internal stack inspection.

Figure 1: Visible cracks sighted on outer concrete shell of the 320 Exhaust Stack

The inspection report warned that the stack was “no longer viable for continued operation without notable safety and economic risk”, with a recommendation to remove and replace this stack within 24 months.

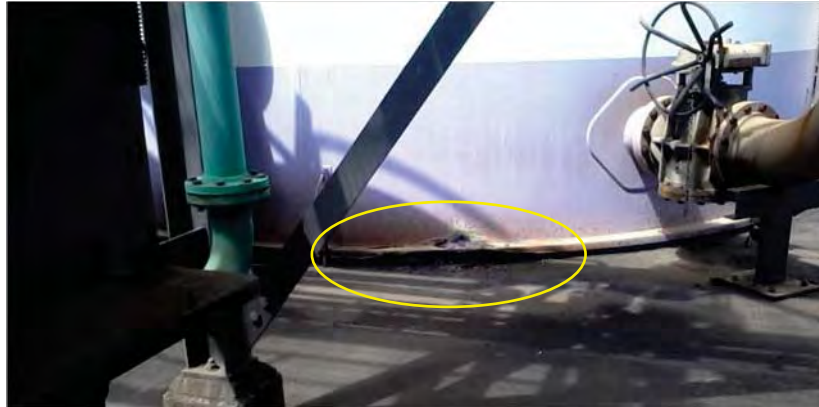
Figure 4: Significant signs of corrosion sighted in the floorplate of 355-1961

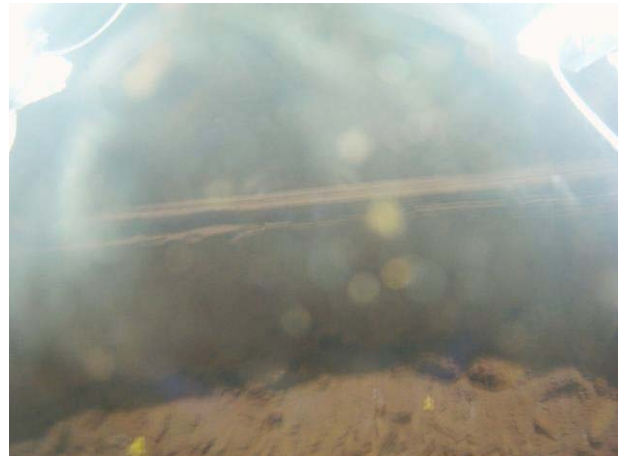
- Deterioration of brickwork observed on all three faces of access door, resulting in loose sections.
- Partial dislodgement of bricks observed on corbel above access door.
- Acidic salt build up has developed in the fine material and close to the walls.
- 30 cubic metres of debris accumulation at base of stack included fine material and portions of the firebrick lining.
- Firebrick lining within 1.6 metres of base of stack was not surveyed due to debris accumulation.

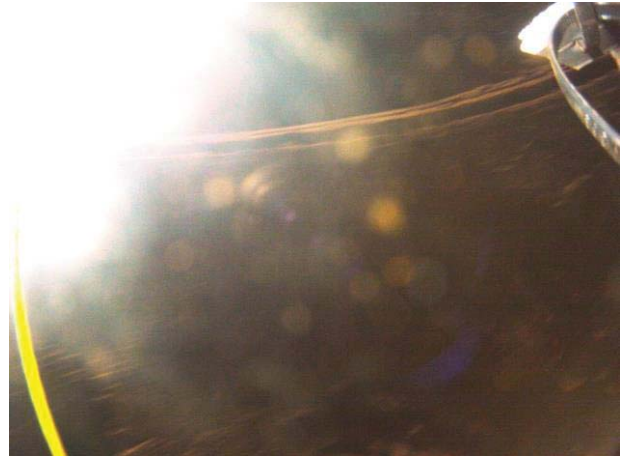
- Partial dislodgment and protrusion of firebrick lining observed.
- Complete dislodgement of brickwork identified around northern inlet duct.
- Remaining bricks are loose and at risk of falling.
- Corbel 2 was damaged and loose sections remain.
- Cracking of concrete shell was minimal.

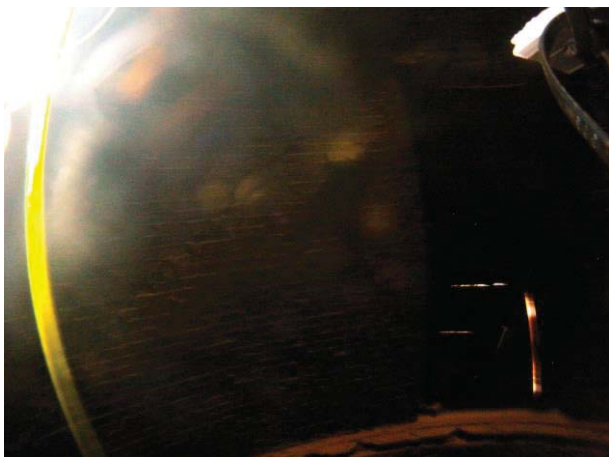
- Partial dislodgement of firebrick lining observed, notably around inlet duct.
- Lining sections were identified to be protruding due to dislodgment,
- Cracking of concrete shell is minimal.

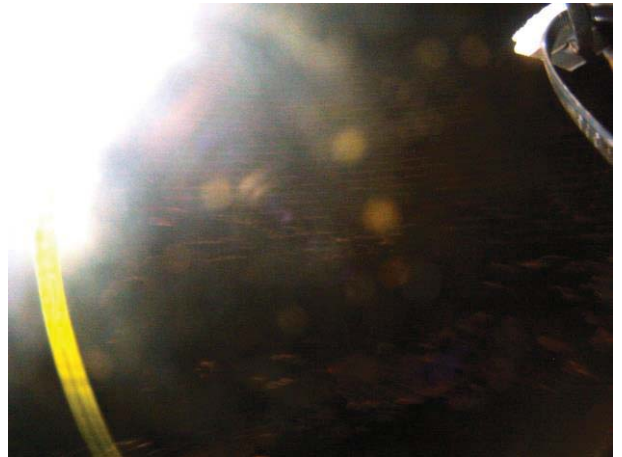
- Partial dislodgement of firebrick lining observed.
- Lining sections were identified to be protruding due to dislodgment.
- Loose fragments identified on Corbel 3.
- Cracking of concrete shell was dominant on southern half, with some seepage of acidic material through the cracks noted.

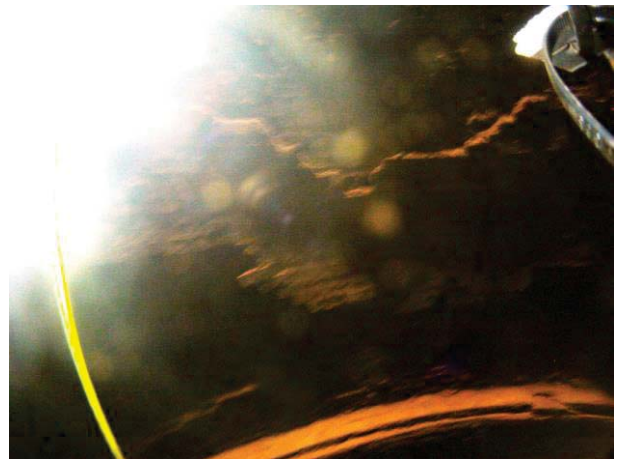
- Complete dislodgement of firebrick lining observed, exposing concrete shell to acidic environment.
- Approximately 3% total firebrick lining area is missing from this area of dislodgment.
- Remaining brickwork is loose in locations
- Loose fragments identified on Corbel 4.
- Concentrated locations of acidic material present in fines accumulation, as evident by the “moist” look of fines.
- Cracking of concrete shell was dominant on eastern and western faces, with seepage of acidic material through the cracks noted.

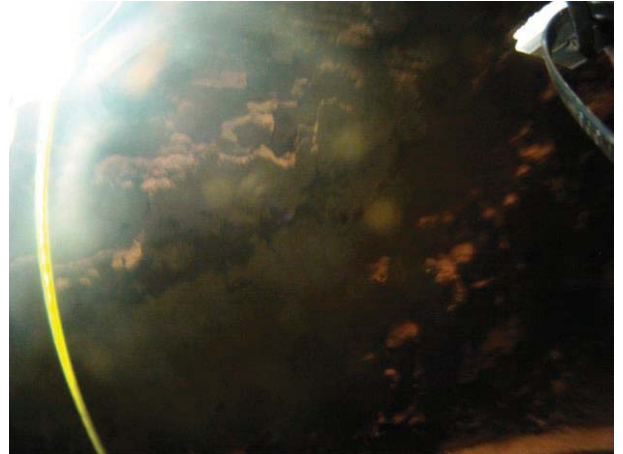
- Partial dislodgement of firebrick lining observed, resulting in the protrusion of sections.
- Loose fragments identified on Corbel 5.
- Concentrated locations of acidic material present in fines accumulation, as evident by the “moist” look of fines.
- Cracking of concrete shell was dominant on southern face, although was observed all around with seepage of acidic material through the cracks noted.

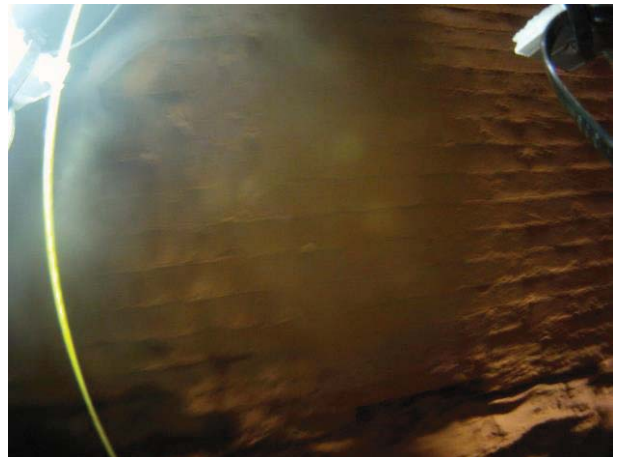
- Complete dislodgement of firebrick lining (of approximately 1.5 m height) observed above Corbel 6.
- Dislodged section equates to approximately 1.5% of total firebrick lining missing.
- Large sections of firebrick lining appear to be sagged, likely due to inadequate support as a result of the missing section.
- Cracking of concrete shell was dominant on southern face, although cracks were observed all around with seepage of acidic material through the cracks noted.

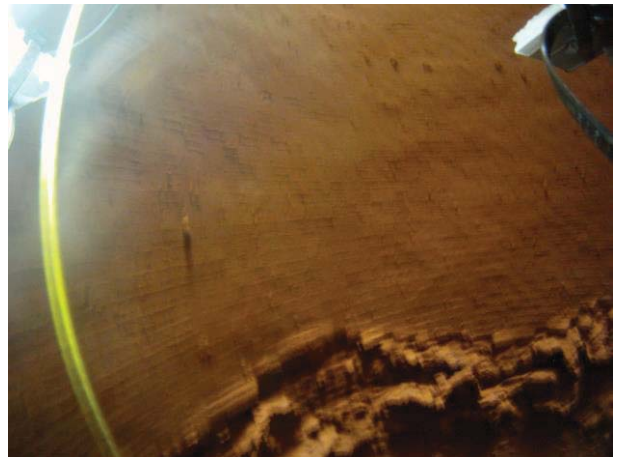
- Complete dislodgement of firebrick lining (of approximately 1.5 m height) observed above Corbel 7.
- Dislodged section equates to approximately 1.5% of total firebrick lining missing.
- Large sections of firebrick lining appear to be sagged, likely due to inadequate support as a result of the missing section.
- Cracking of concrete shell was dominant on southern face, although cracks were observed all around with seepage of acidic material through the cracks noted.

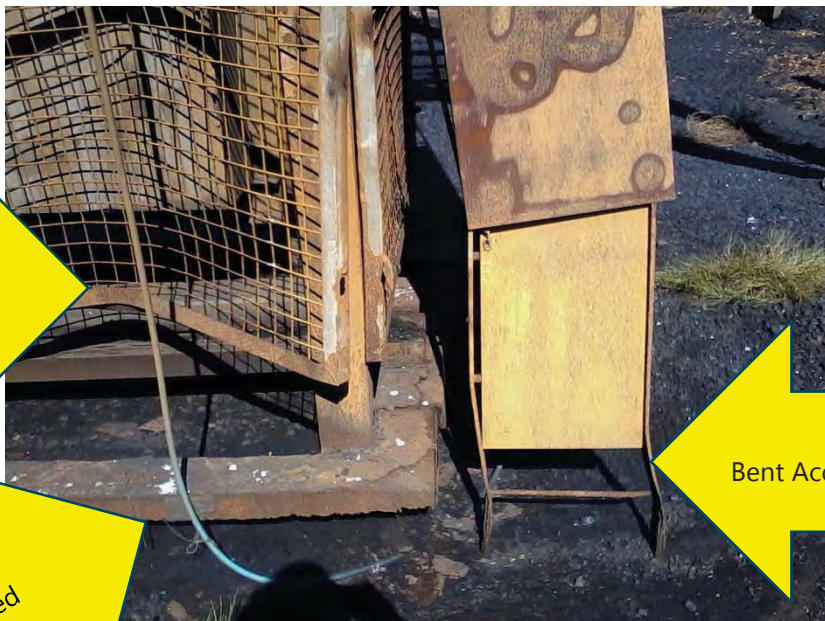
Bent Gravity Take Up
guard frame

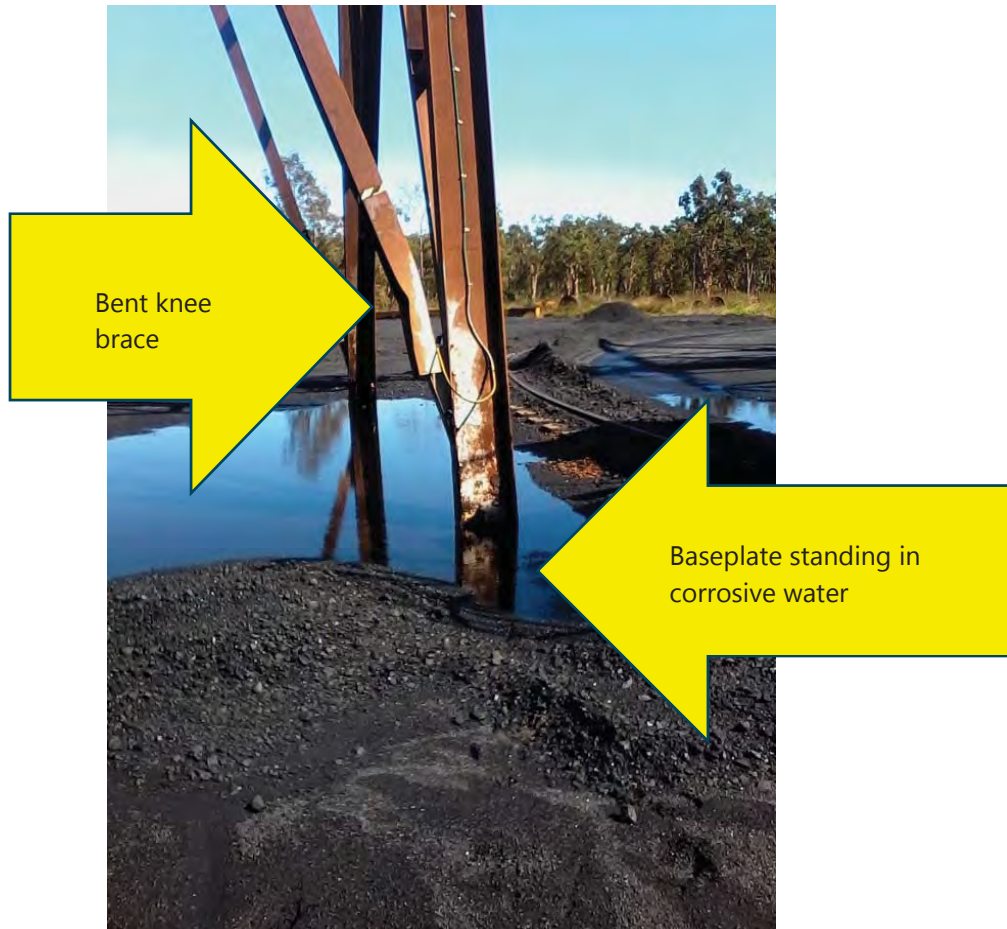
Severely corroded
member

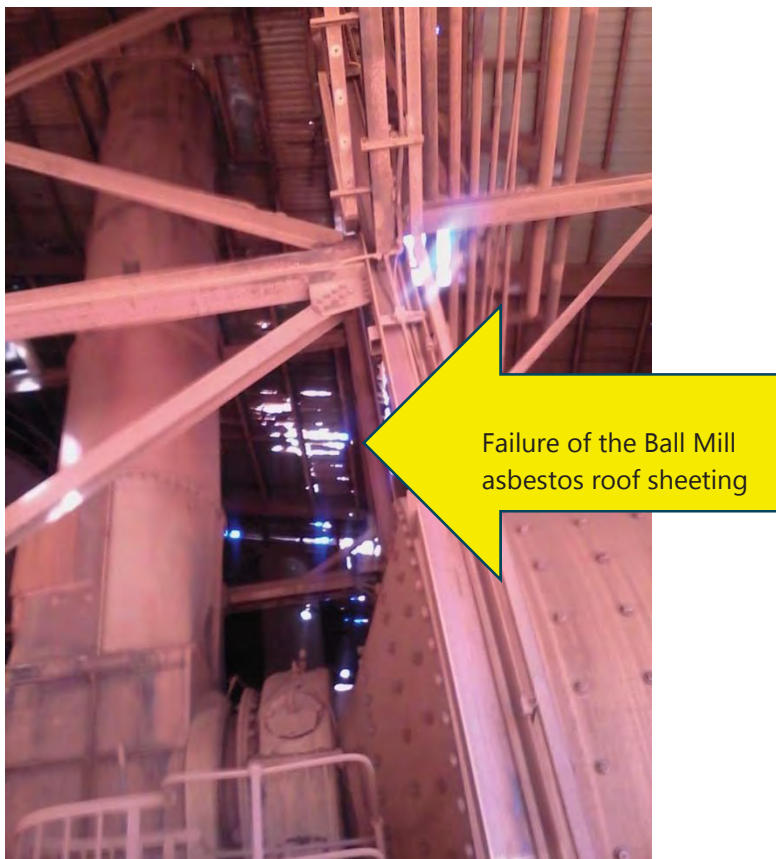
The corrugated asbestos roof sheeting of the Ball Mill had failed in several locations dropping asbestos fragments onto the floor area and allowing weather and rain to penetrate and water to pond within the building.

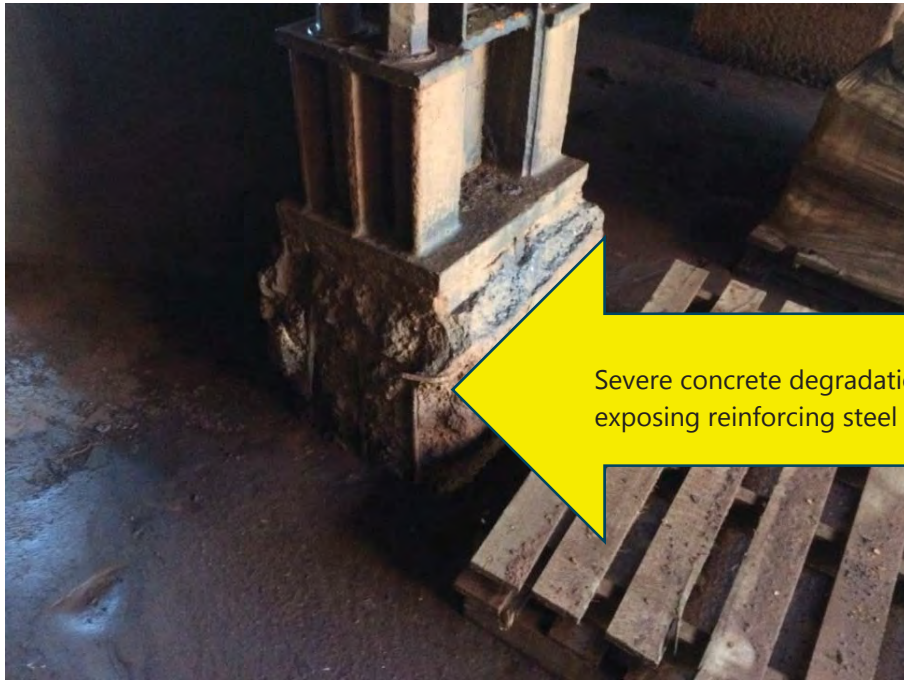
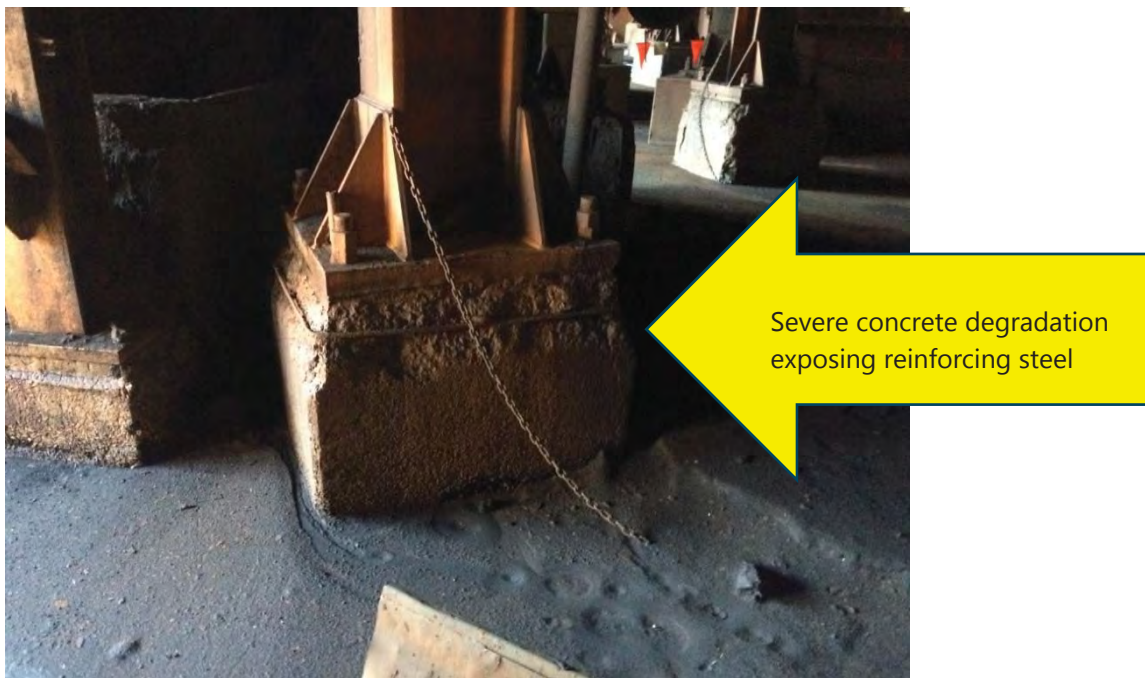
The Roasters area also exhibited examples of extremely severe concrete degradation exposing reinforcing steel to corrosion as shown in the following photos.

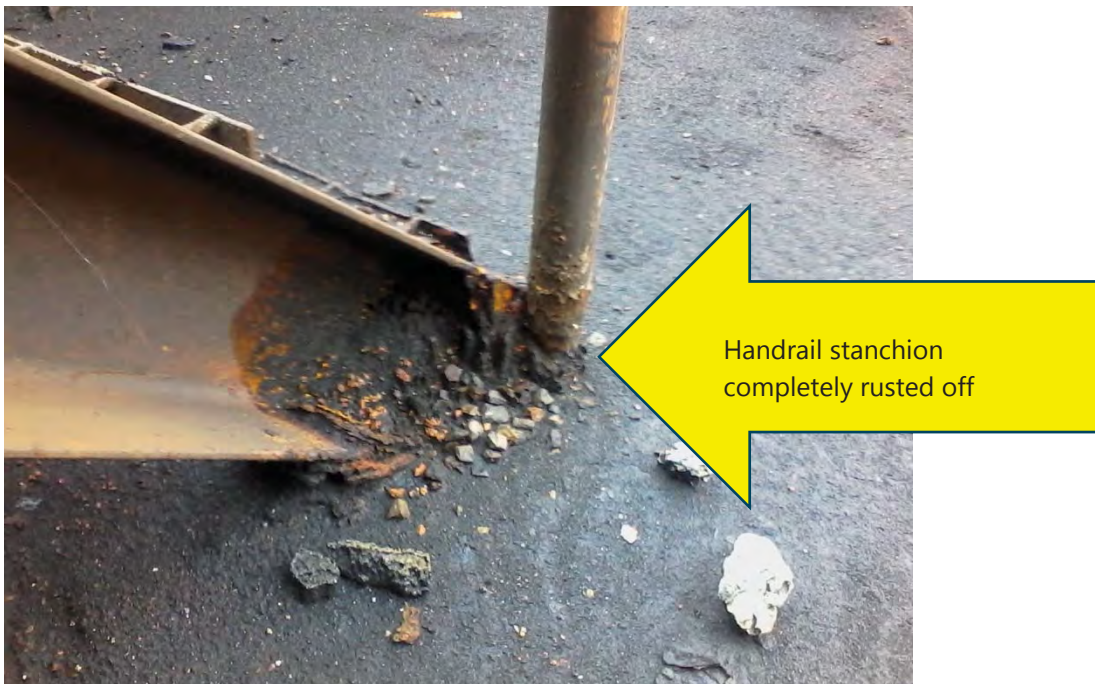
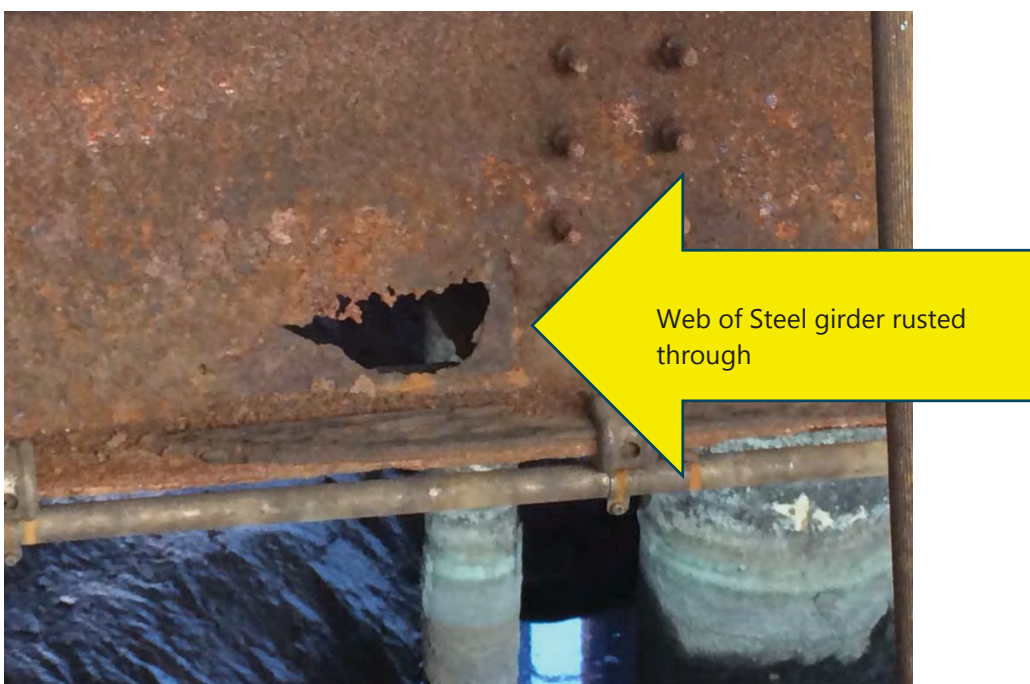
Area 340 Leaching particularly the Aerator tank farm displayed some of the worst corrosion and neglect seen at the Yabulu Refinery. Structural steel members have been entirely corroded through portions of their cross-section such as their web or flanges as can be seen in the following photos.

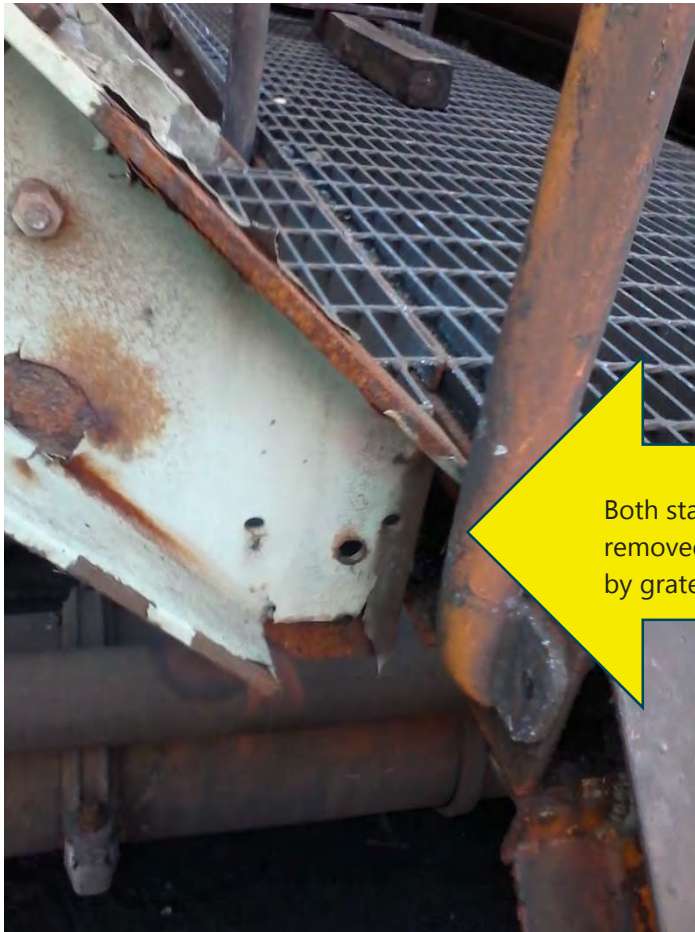
Both stair stringer cleats removed. Stair is only supported by grated stair tread

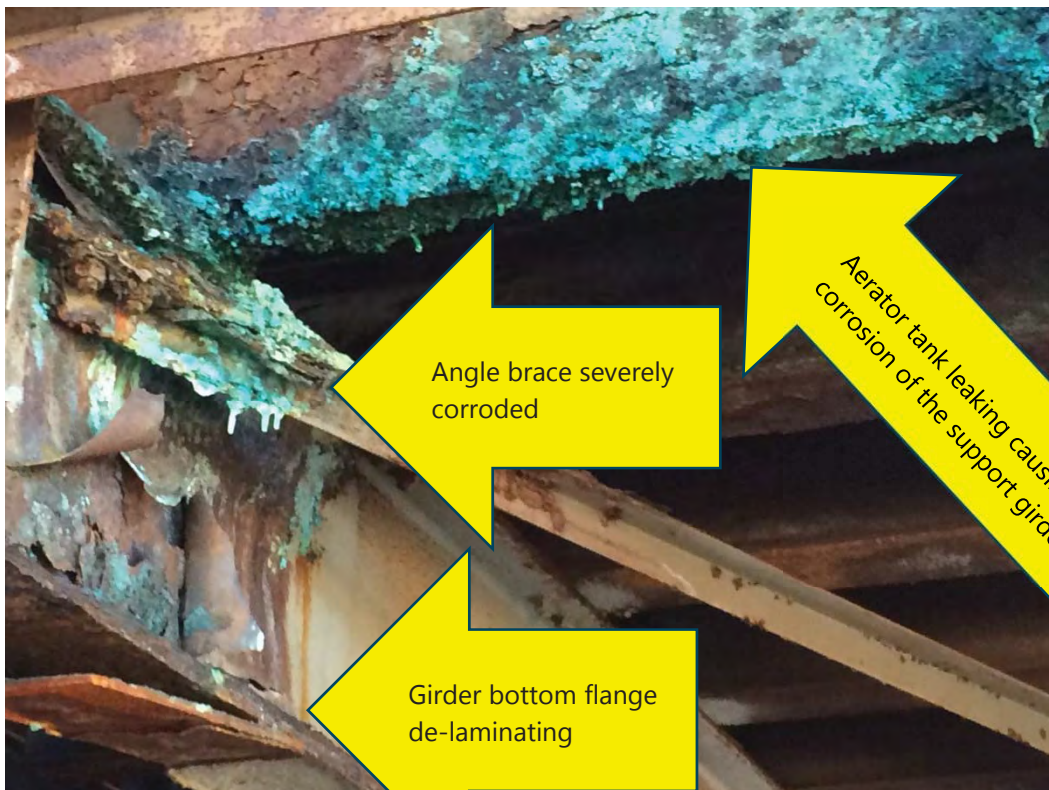
Angle brace severely corroded
