Subject: FW: QN - 16 February - Roaster incident update
Attachments: 2016 02 16 330-1401 Roaster 1 EVD Explosion Post Incident External Damag....pdf

POST-INCIDENT EXTERNAL DAMAGE SURVEY

Equipment No:	330-1401 Roaster 1	Cintellate:	INC-36529
Inspected By:		Inspection Date:	16/02/2016

MAJOR HAZARD FACILITIES AUDIT REPORT

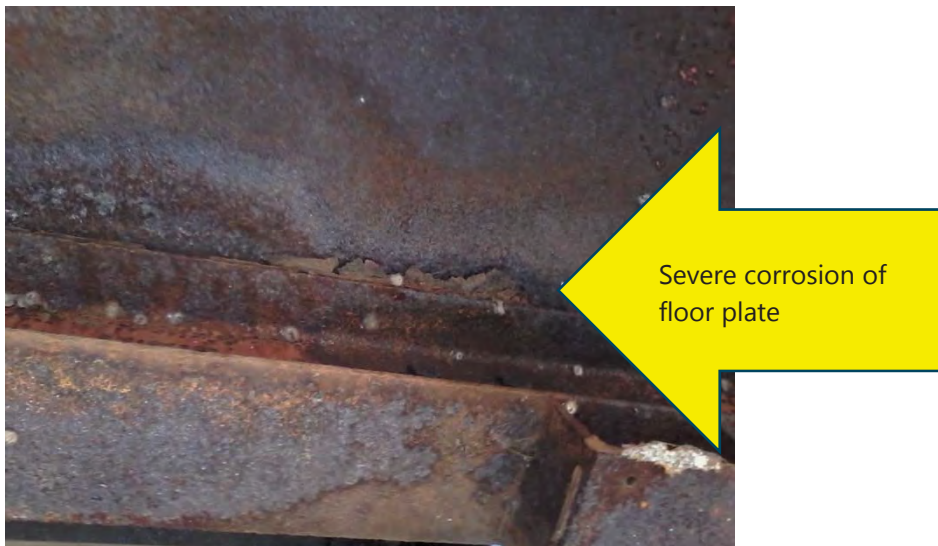
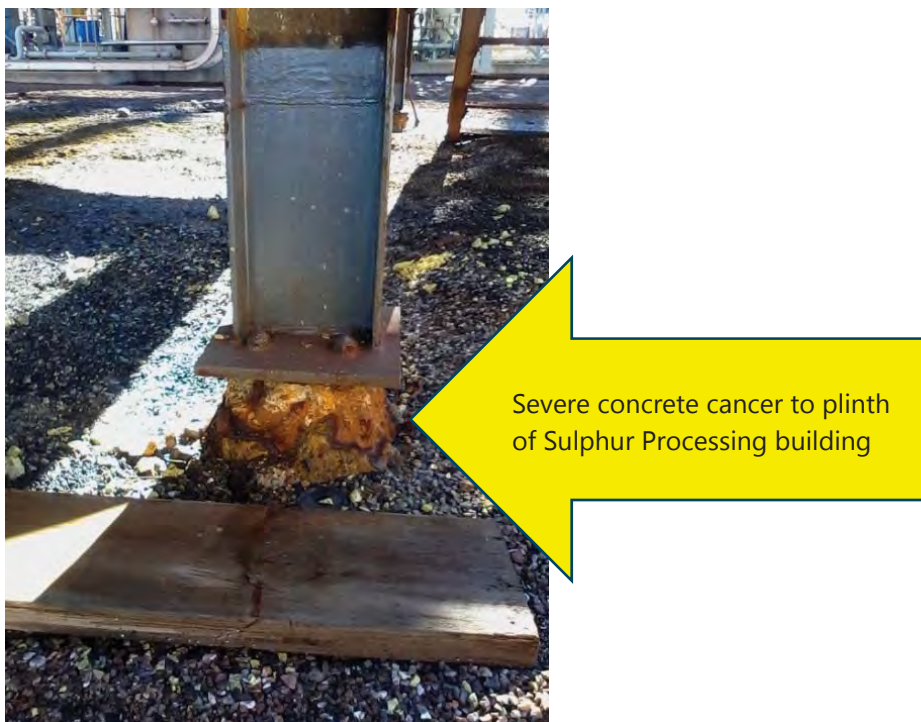
Structural deterioration of the gas plant structures was significant in areas exposed to the sulphur handling and the 420-2507 stair tower.

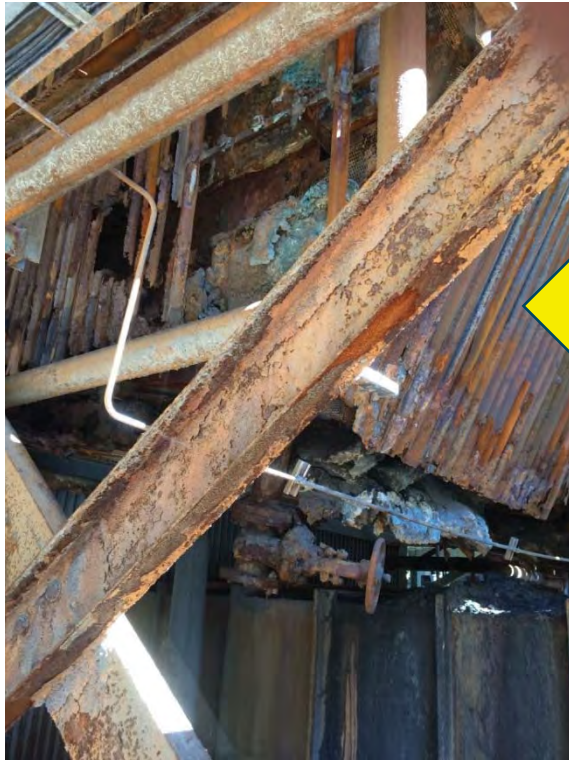
Severe corrosion of
structural members and
