Subject: FW: QN - 16 February - Roaster incident update
Attachments: 2016 02 16 330-1401 Roaster 1 EVD Explosion Post Incident External Damag....pdf

POST-INCIDENT EXTERNAL DAMAGE SURVEY

Equipment No:	330-1401 Roaster 1	Cintellate:	INC-36529
Inspected By:		Inspection Date:	16/02/2016

MAJOR HAZARD FACILITIES AUDIT REPORT

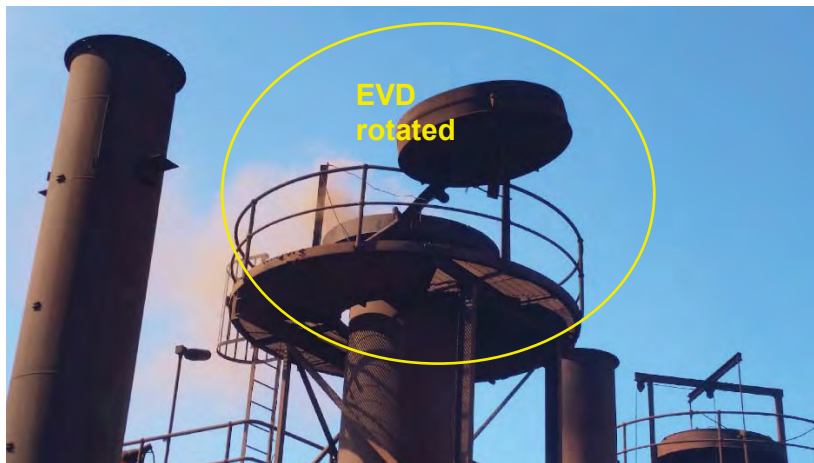
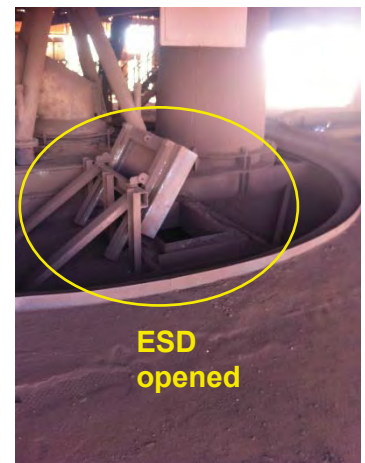
1. Preliminary investigations have commenced on Roaster 1 integrity.
2. Appears to be no apparent damage to Roaster 1 external structure.
3. Unable to confirm the condition of the internals of Roaster 1 at this stage.
4. The vessel is to have internal inspections done to assess the condition of the refractory lining- work is continuing.
5. The explosion lifted the explosion safety door and caused the emergency vent dampener (EVD to rotate approximately 180° from its normal position. Pictures of the damage were provided in emails sent during this discussion, and are presented below:

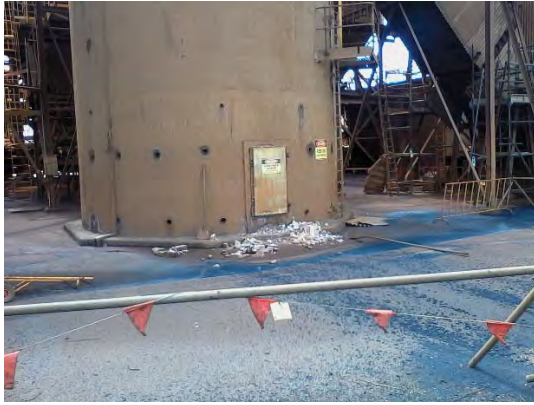
From outside the exclusion zone, the inspector sighted numerous vertical cracks around the outer shell of the stack. The size of these cracks varied, with some cracks ranging up to an estimated 20-30m in length (Figure 1). A small pile of bricks were observed at the base of the stack at an inspection door (Figure 2). It was reported that those bricks were from the internals and were removed to facilitate the internal stack inspection.

Figure 2: Bricks lie at entrance of the stack

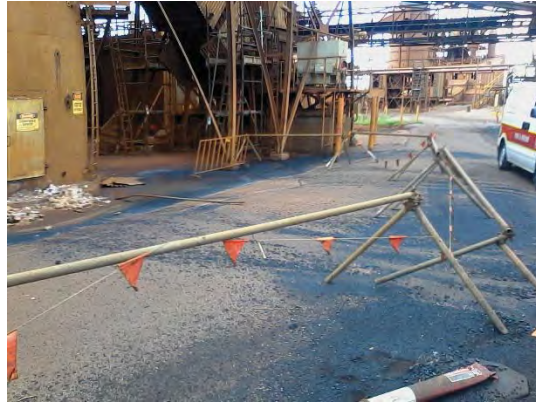
The inspector conducted a visual inspection of the Area 320 Exhaust Stack. It was observed that an exclusion zone had been set up around the stack as has been reported by the Administrators (Figures 2 and 3). A number of barrier warning tags were sighted on the barricade (Figure 2). The tags were heavily faded suggesting that the tags had been present for some time. However the inspector noted that the information "Poor Condition of the Stack" was etched onto one of the tags sighted.

Figure 3: Temporary barricading surrounds the stack

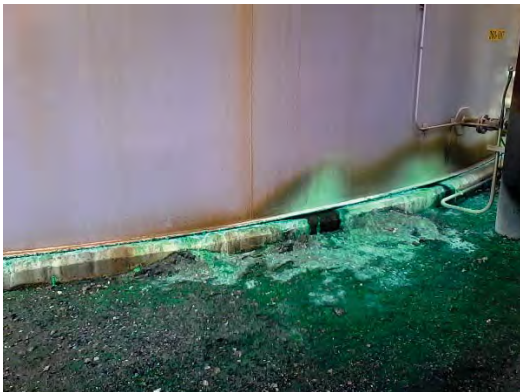
- 360-1917 Special Product Liquor Aeration/Storage Tank 2: there appeared to be a leak from the floor of the tank. A bright green deposit was found around the perimeter of the vessel (Figure 6), with several noted damp spots found on the concrete berm supporting the tank (Figure 5). It does not appear that this issue had been detected prior to this audit.
- 355-1961 Raffinate After-Settler (Coalescer): a notable hole appeared to have developed between the floor plate of this tank and its supporting berm, with sighted evidence suggesting that this plate had corroded (Figure 4). It was not determined at this audit as to whether there were any contents within this tank presently.

Figure 5: Damp spots found on the concrete berm of 360-1917

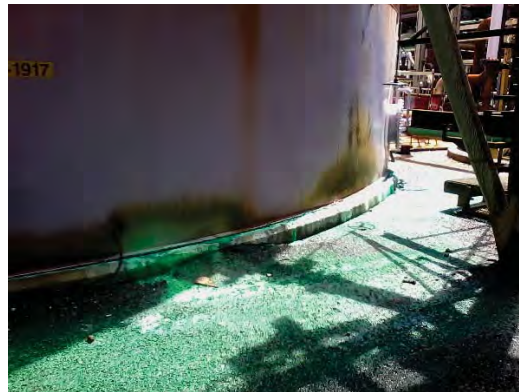
Figure 6: A bright green deposit was found around the perimeter of 360-1917

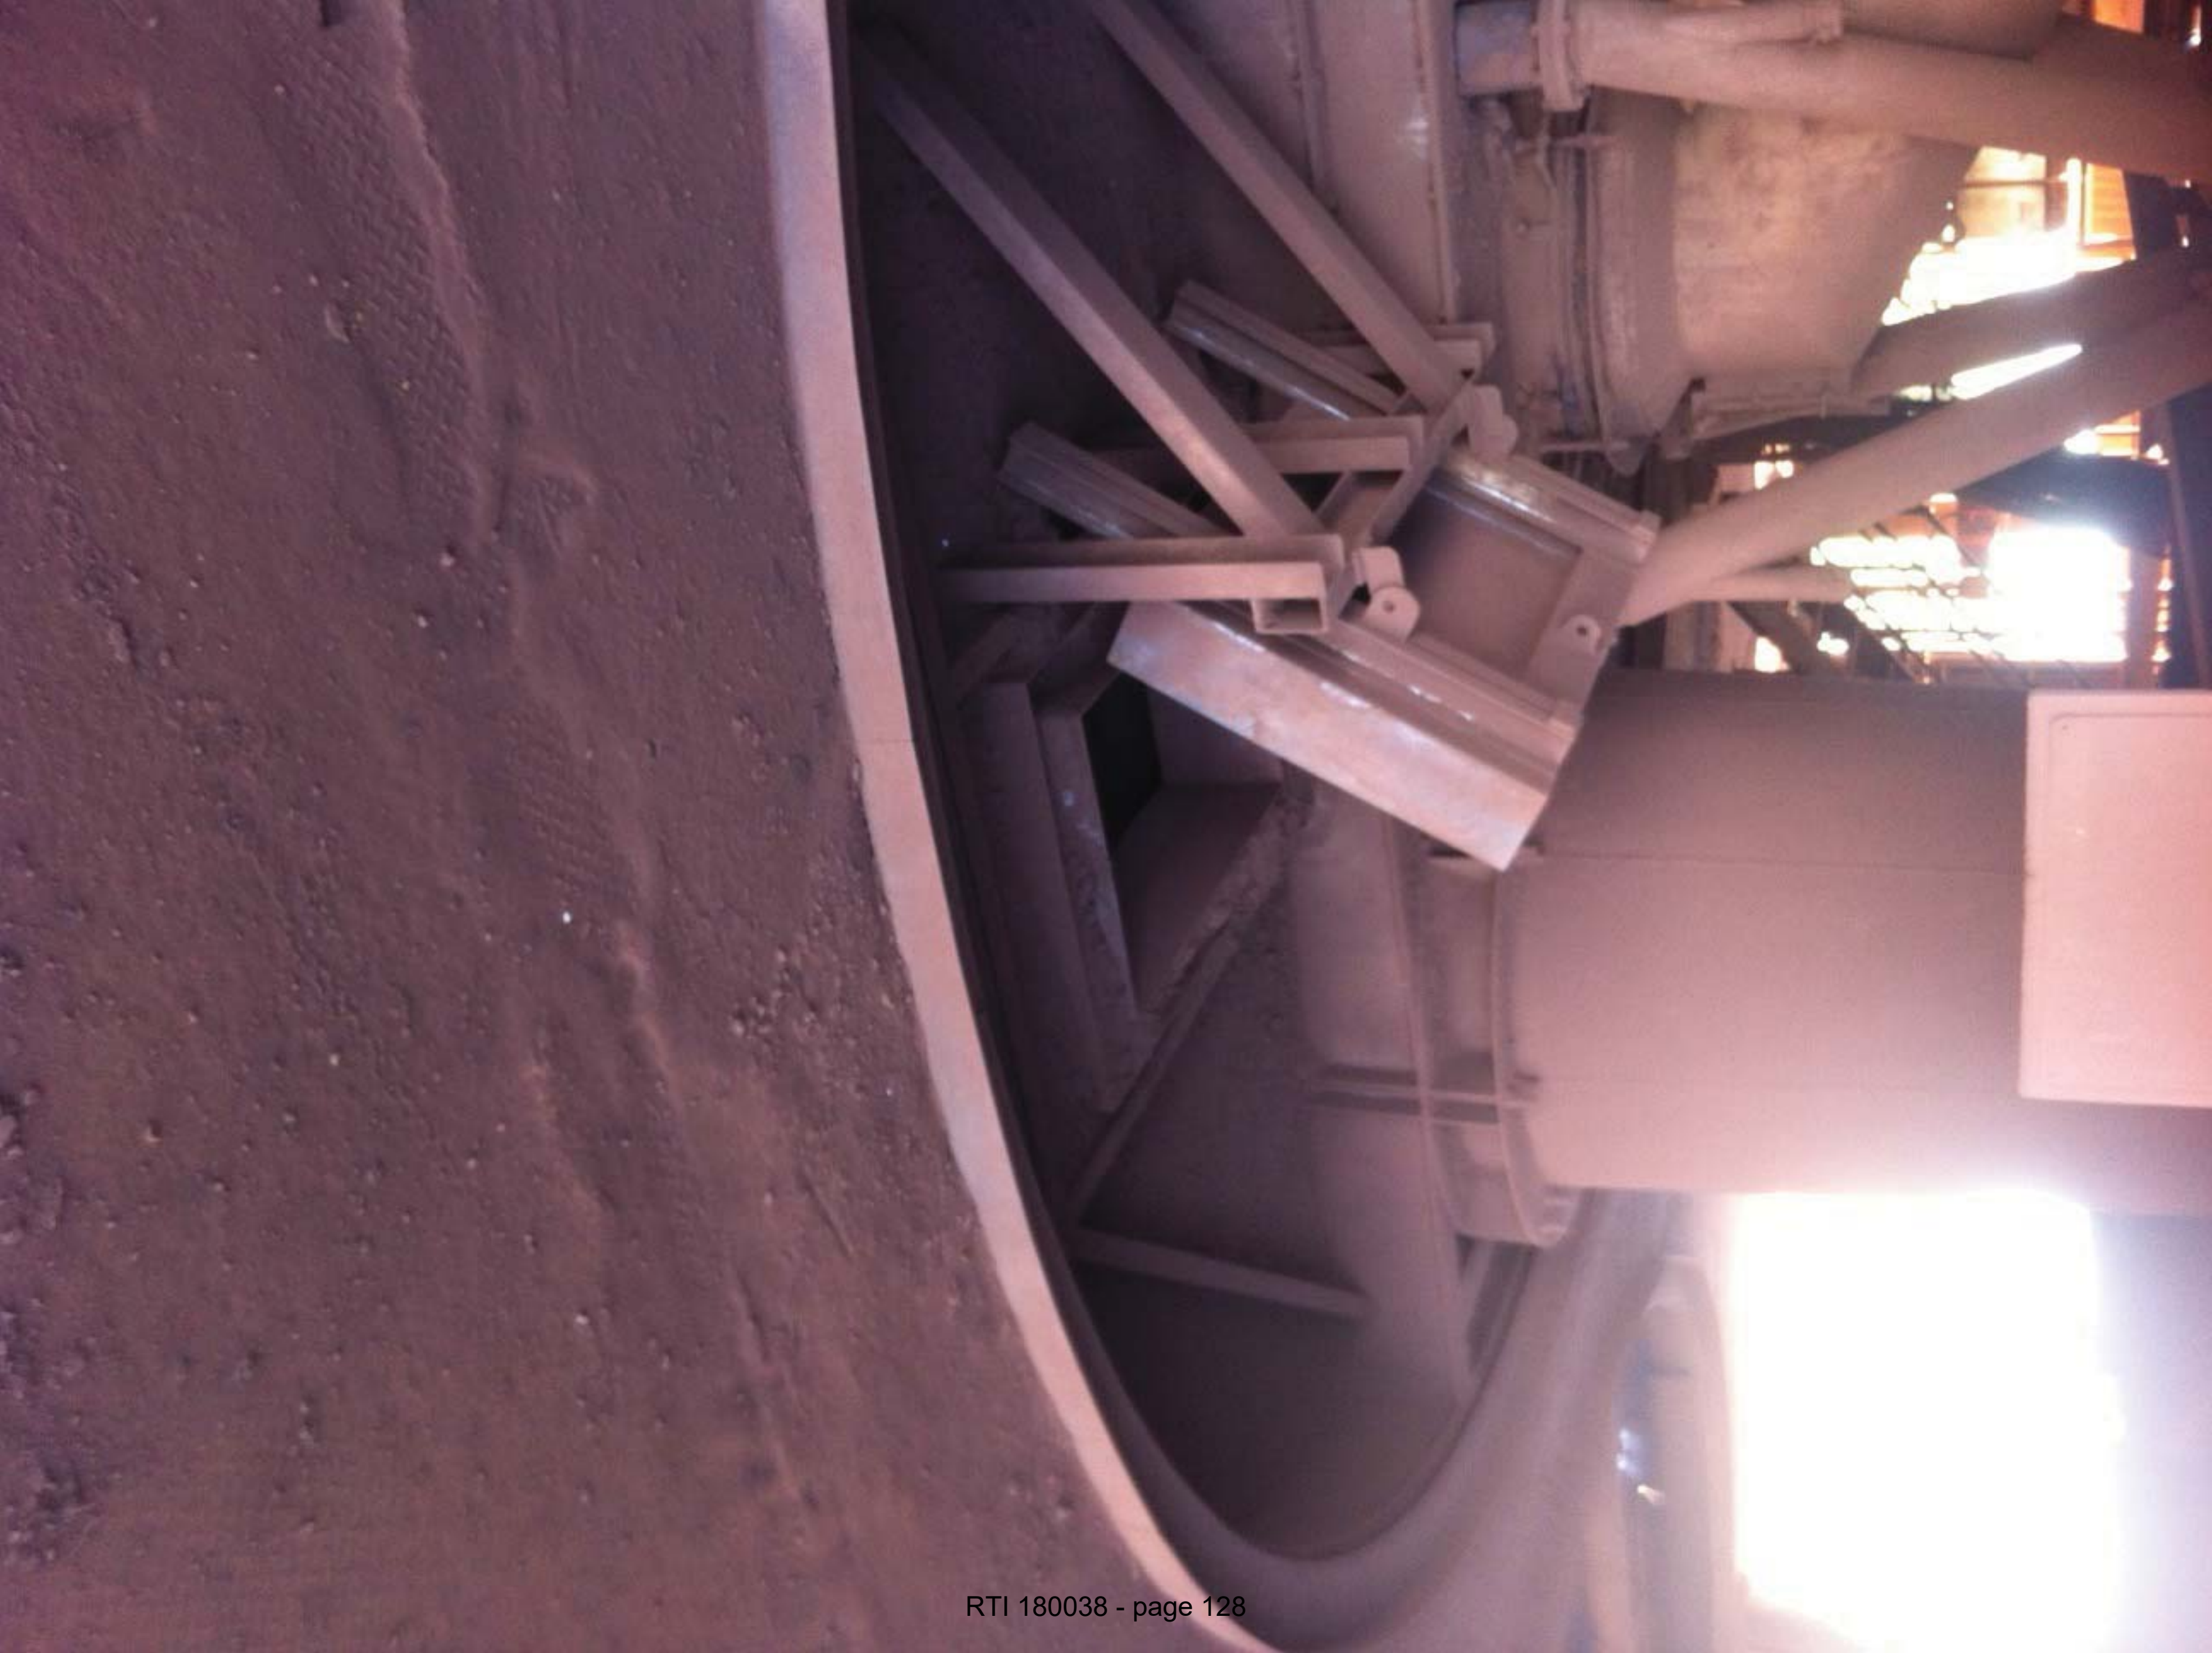
photo l9

This photo depicts the explosion door working as per design on level 9. The reset involves lowering the door back into position.

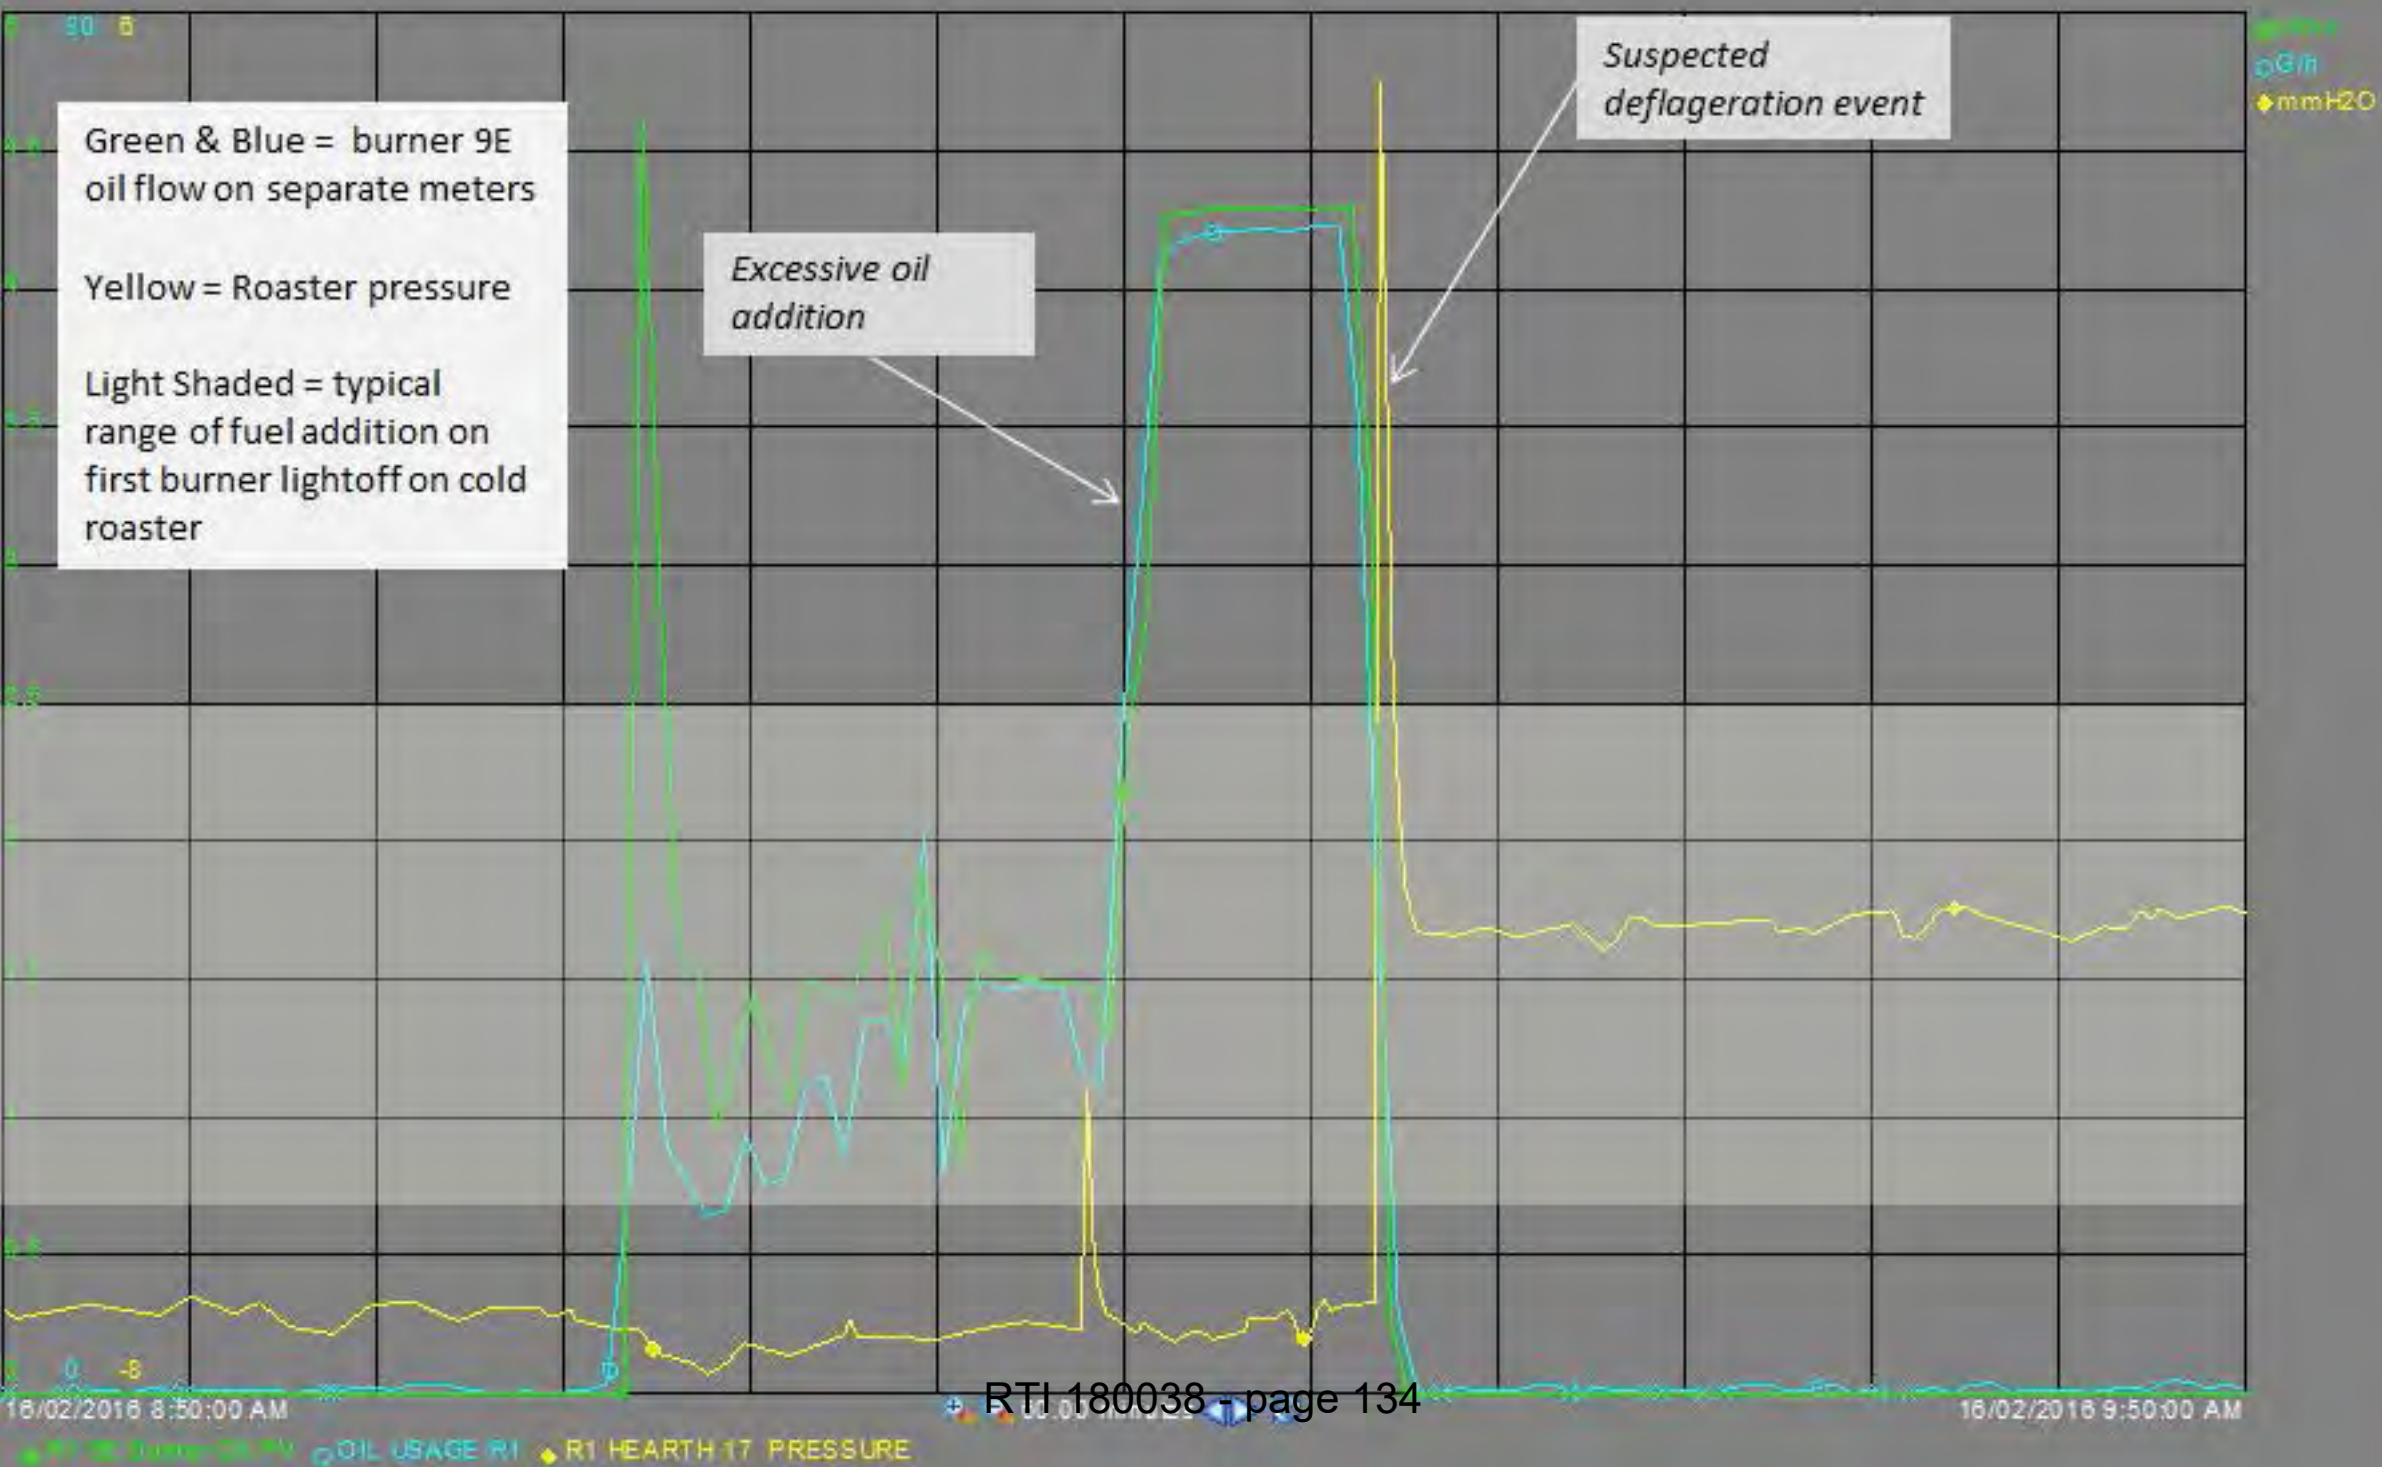
Figure 1: Burner 9E incident trend

The reason for the excessive oil addition period is not yet known. Operator error and/or burner malfunction are being investigated. The burner trend from the incident is shown below (Figure 1).

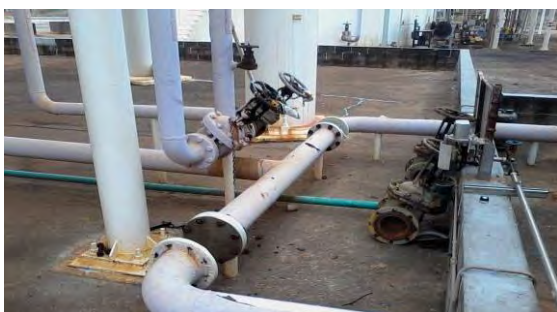
The auditors sighted and were provided additional evidence showing that the sphere has been positively isolated via the use of blinds and spool piece removal (Figure 8.1). Pipelines no longer in use have now been decontaminated downstream of the sphere isolations. These findings overall are welcomed by WHSQ.

Figure 8.1: AHS Sphere positively isolated via spool piece removal

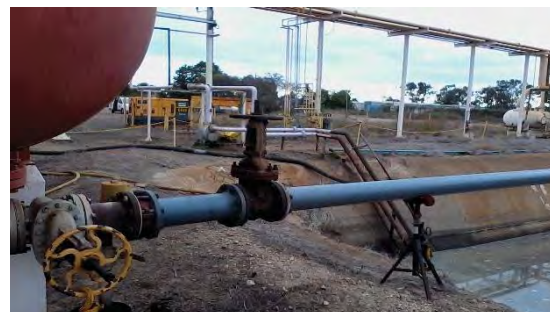
The oil dump system mounted to the ammonium hydrosulphide spill containment bund has now been automated (Figure 8.2). Local fixed gas detectors (mounted on the bund walls surrounding the sphere) are set to detect any rouge hydrogen sulphide emissions within the area. It was noted that there are no gas detectors located within close proximity of the spill containment bund itself. WHSQ suggests that further consideration be given as to whether additional gas detection is required at the spill containment bund.

Figure 8.2: Installation of automated dump valve on 450-1909 Oil Tank

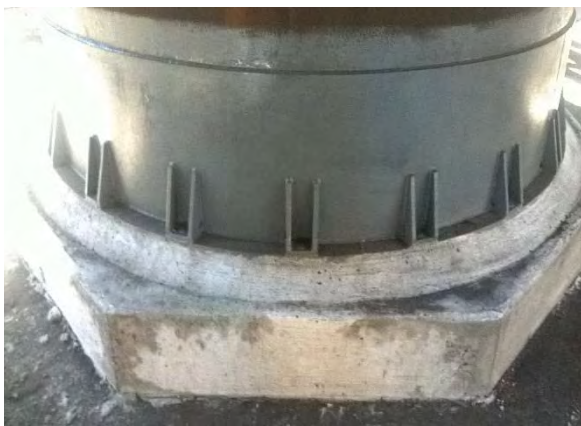
Following the issue of these notices QNS have progressively acted to address these structural integrity concerns. It was observed at this audit that QNS have made significant repairs to the skirt and shell a number of vessels in this area, including 352-1111 Absorber Column (Figure 8.6), and all Tailing (Figure 8.5) and Magma Stills (Figure 8.7). The scope of the work done to repair these vessels appears to be beyond the requirements stipulated in the notices issued.

Figure 8.5: Example of repairs made to 352 Tailing Stills

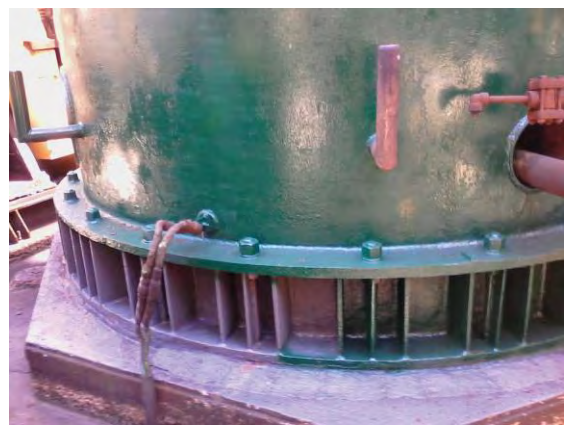
Figure 8.6: Repairs made to 352-1111 Absorber Column

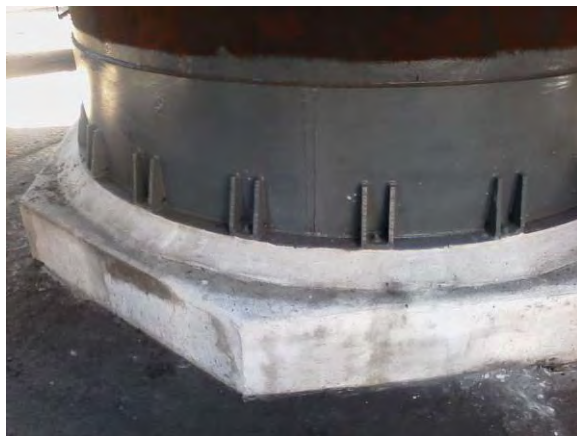
Figure 8.7: Example of repairs made to 352 Magma Stills

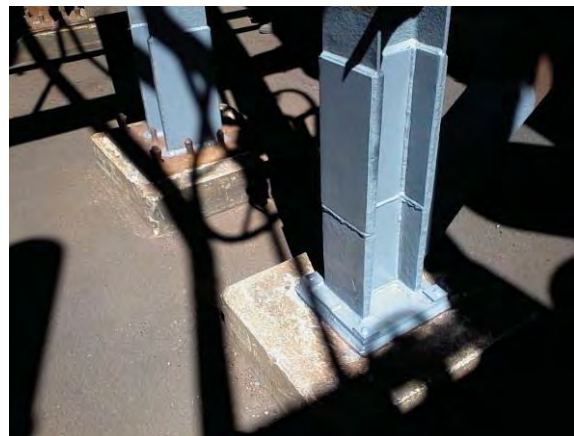
It was also identified that QNS have recently commenced work to repair other infrastructure in this area, such as walkways and stairs (Figure 8.8). WHSQ welcomes these findings.

Figure 8.8: Recent repairs to infrastructure supporting walkways at 352 Tailings Still Area

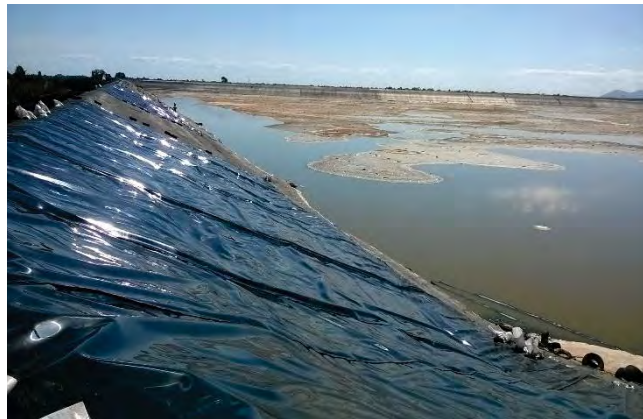
It was reported that work to the Brine Dam is nearing completion, with repairs expected to be complete by the end of September 2017. The auditors observed the installation of a PVC lining within the Brine Dam (Figure 8.9). Once the lining to the Brine Dam is fully installed, QNS plans to commence the transfer of ammoniacal solutions from the Area 340 Thickener area to the Brine Dam. WHSQ welcomes this action.

Figure 8.9: Repairs to Brine Dam

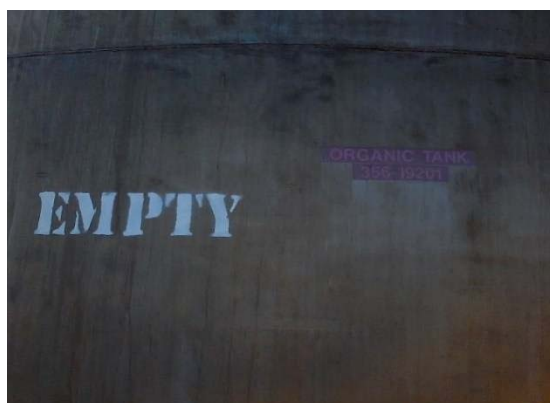
On inspection of these vessel, it was identified that both vessels were marked as being "empty" (Figures 8.10 and 8.11). This was not the case. QNS representatives committed to removing the incorrect "empty" marking of these vessels immediately. No notices were issued based on this commitment.

Figure 8.10: Incorrect marking on 356-19201

P1 RECOMMENDATION 4: Remove the incorrect "empty" marking on 356-19200 and 356-19201.

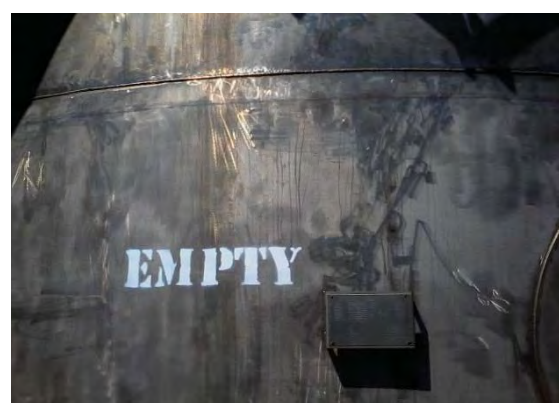
Figure 8.11: Incorrect marking on 356-19201

There were no markings on either 356-19200 or 356-19201 to identify that these vessels were storing organic solvent. The organic solvent appears to be a schedule 11 (hazardous) chemical, namely a category 4 flammable liquid. The amount in these vessels appears to be in quantities which exceed placard thresholds.

C 1: Ensure 356-19200 and 356-19201 are appropriately placard as per Schedule 13 requirements.

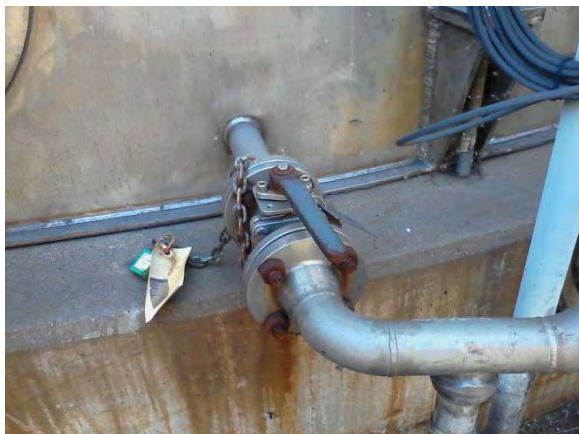
It was noted that both storage tanks were not fully isolated as close as possible to the tank itself (Figure 8.12). A pump which was connected and opened to 356-19201 was found to be leaking organic solvent (Figure 8.13).

Figure 8.12: 356-19201 not isolated at tank

Existing site conditions require all tanks and vessels containing hazardous chemicals remain isolated by double block and bleed, lock closed drain point and lock closed as close as possible to the source whilst the facility is not manufacturing. This observation appears to be a breach of this condition. A commitment was made to rectify this non-conformance by the close of business that day, and as such no notices were issued.

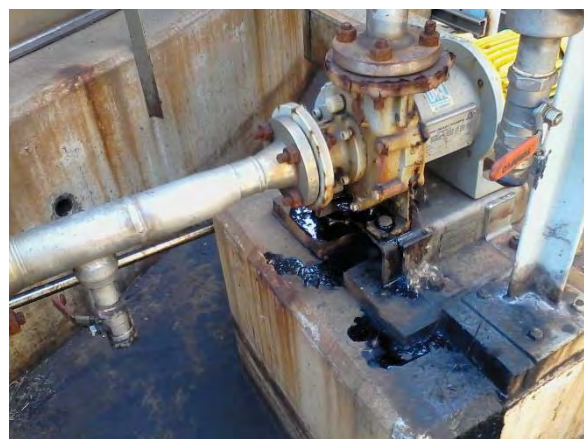
Figure 8.13: Leaking organic solvent from pump connected to 356-19201

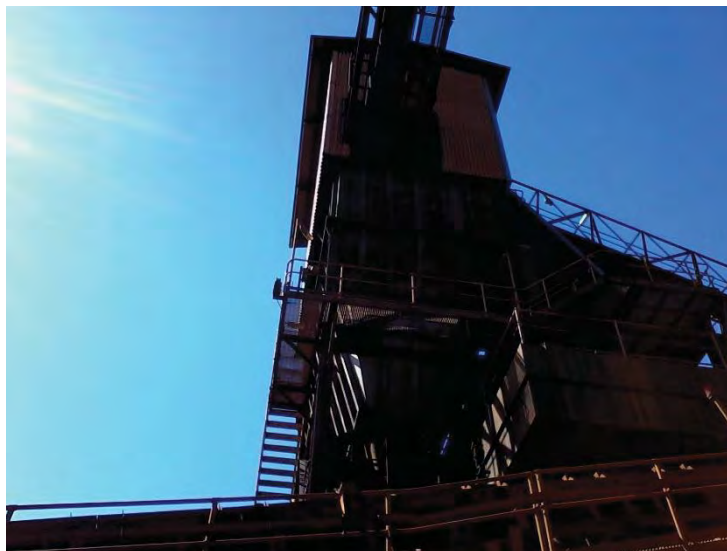
Further AC sheeting was cut and removed from 320-2661 Coal Bunker 1 Dryer building as it was deemed probable that a similar wind event would result in further sheeting from the building to be dislodged. The area beneath the dryer building remains barricaded from general entry. QNS have reportedly commissioned an RPEQ accredited structural engineer to review their asbestos register in order to identify relevant plant areas that continues to house asbestos containing materials. Inspection of these areas containing asbestos has commenced to identify whether it is possible for other AC sheeting or materials to become dislodged or mobilised in a high wind event. Preliminary findings suggest that the building which houses the 320 Ball Mill will require further attention. QNS has reported that they will undertake all necessary repairs once the proposed inspection work for the site is complete.

Figure 8.14: 320-2661 Coal Bunker 1 Dryer Building

P1 RECOMMENDATION 5: Ensure all loose infrastructure, including but not limited to cladding, sheeting, and insulation, are removed or secured prior to commencement of the upcoming (summer) storm season.

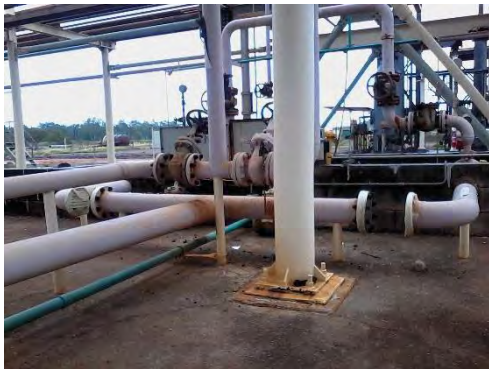
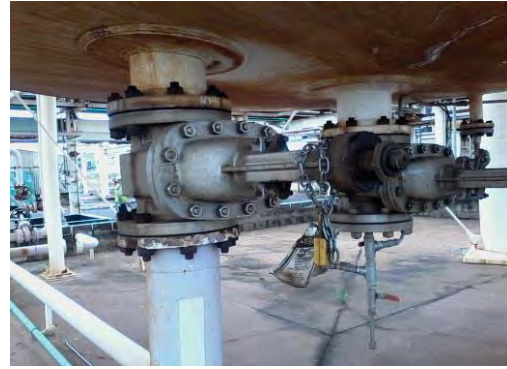
- There were no changes made to the condition of the Ammonium Hydrosulphide (AHS) sphere when compared to the recent WHSQ audits. The sphere remained isolated from plant by the use of blinds and spools removal.

Photos of the AHS sphere positively isolated

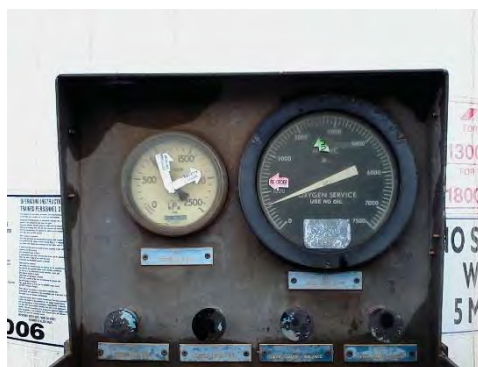
- The required nitrogen inventory is now much lower due to elimination of the catalyst and the non-operational status of plant. The QNS representative stated that nitrogen inventory will be reordered if the pressure of the nitrogen tank drops down to 300 kPa. It was noted that the "reorder" labels (which were based on the former operational need) on the level and pressure gauges of the nitrogen tank were no longer applicable and did not reflect when nitrogen should be reordered.

Photo of the gauges on the nitrogen tank- AHS sphere

P1 RECOMMENDATION 1: QNS should revise the “reorder” labels on the pressure and level gauges of the nitrogen tank at the AHS sphere as per the existing operational need to reflect when nitrogen should be reordered.

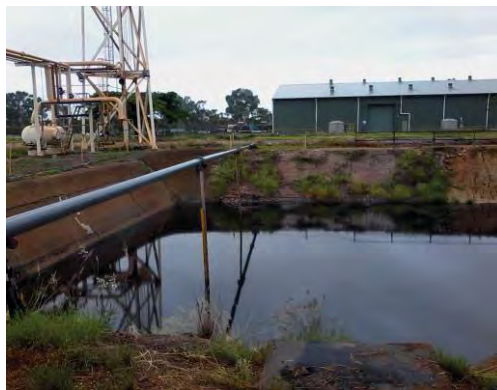
- Smoke from an overheated UPS battery bank in the Substation 540 activated the fire panel of the HV switch room on 4/02/2018. As a result, the site power tripped and activated the emergency system which included the oil dump system at the AHS sphere which dumped oil in the expanded bund. It was noted that the dumped oil covered the surface of the bund. It appeared that the oil dump system functioned as per its design intent.
- The QNS representatives reported that the oil tank is refilled and this was confirmed by the auditors.

Photo of the oil dumped in the newly extended bund- AHS sphere

- The auditors sighted that the expanded part of the earthed bund had not been lined with any impervious coating as committed by QNS in the last WHSQ visit. It was unclear when work will be commenced to address the matter. Section 5.8.3 of Australian Standard AS 1940:2017, “The storage and handling of flammable and combustible liquids” recommends that bunds shall be sufficiently impervious to retain spillage and to enable recovery of such spillage.

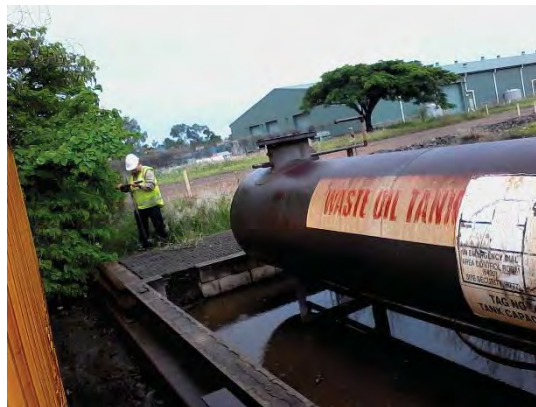
- When the auditors tested the bund valve associated with a tank containing waste oil in the 420 area, it did not appear to be of a “normally closed” type. It sprang back to open. In an event of a chemical leak from the tank, an opened bund valve defeats the purpose of the bund.
- Rainwater was accumulated in the bund of the tank. It should be noted that WHSQ has issued Improvement Notices to QNS for ensuring bunds are empty in the previous site inspections. However, on this occasion, the amount of water did not materially impact the bund capacity and therefore, was not deemed to be an imminent risk. It is not good practice and should be emptied promptly.

Photo of the Waste Oil Tank

P1 RECOMMENDATION 3: QNS should ensure bund valves associated with tanks and containers of hazardous chemicals, are maintained in a closed position when not being actively monitored.

P1 RECOMMENDATION 4: QNS should ensure the bunded areas associated with tanks and containers of hazardous chemicals are kept in a state that will ensure sufficient capacity in the event of a failure of the primary containment.

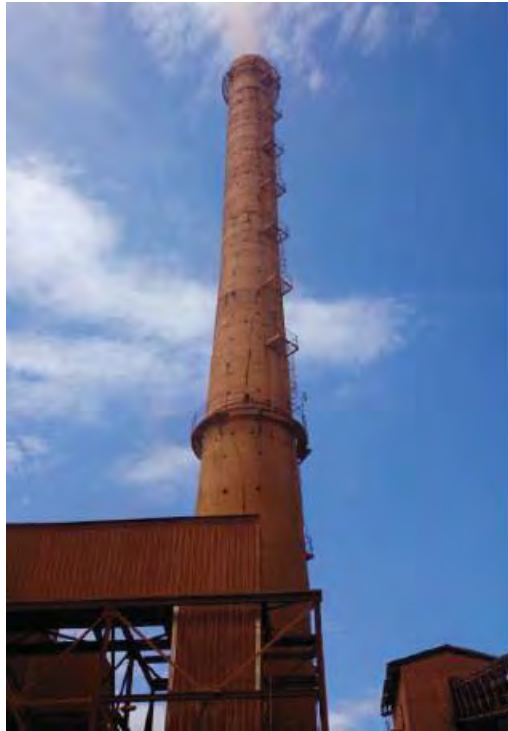
Figure 1: 320-1404 Concrete Stack

The top 30m of the concrete stack was considered to be in a very poor condition. Extensive cracking of the concrete shell was identified. The seepage of acidic material through these cracks, as observed in the 2015 UAV external survey, indicates a number of these cracks are of full thickness and acidic attack is advanced. In addition, the internal firebrick lining for this area exhibits large sections of loss and evidence of sagging.

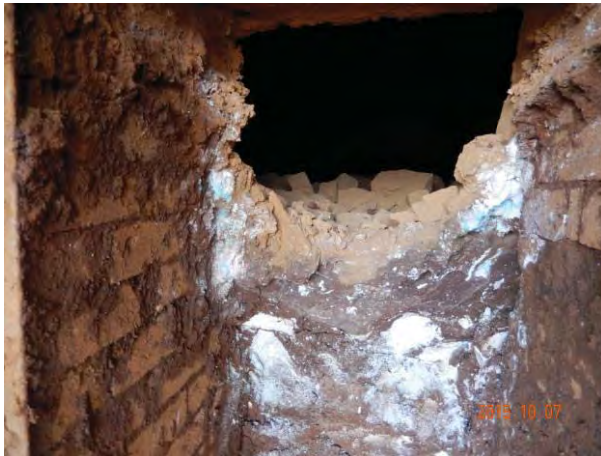
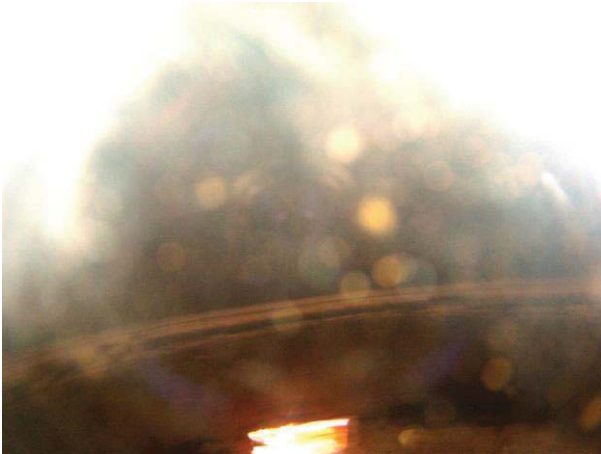
Item: 1
Location: Ground to Corbel 1
Condition Code: 7
Observation:

- Deterioration of brickwork observed on all three faces of access door, resulting in loose sections.
- Partial dislodgement of bricks observed on corbel above access door.
- Acidic salt build up has developed in the fine material and close to the walls.
- 30 cubic metres of debris accumulation at base of stack included fine material and portions of the firebrick lining.
- Firebrick lining within 1.6 metres of base of stack was not surveyed due to debris accumulation.

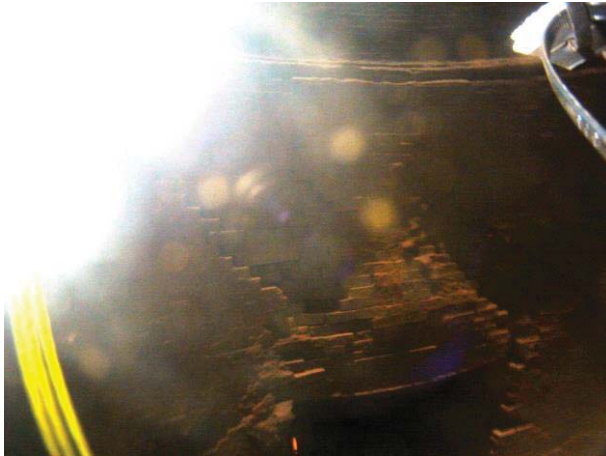
Item: 2
Location: Corbel 1 to Corbel 2
Condition Code: 8
Observation:

- Partial dislodgment and protrusion of firebrick lining observed.
- Complete dislodgement of brickwork identified around northern inlet duct.
- Remaining bricks are loose and at risk of falling.
- Corbel 2 was damaged and loose sections remain.
- Cracking of concrete shell was minimal.

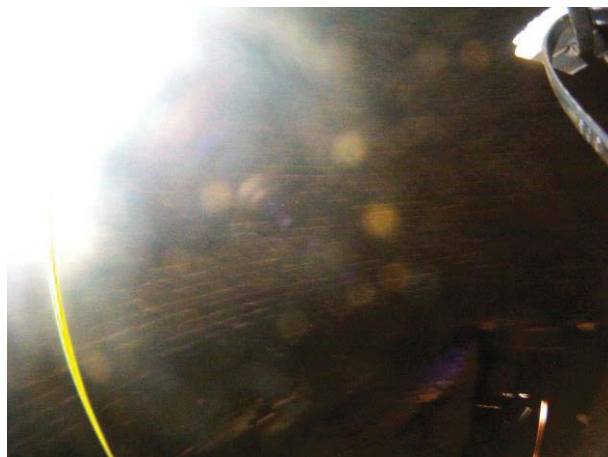
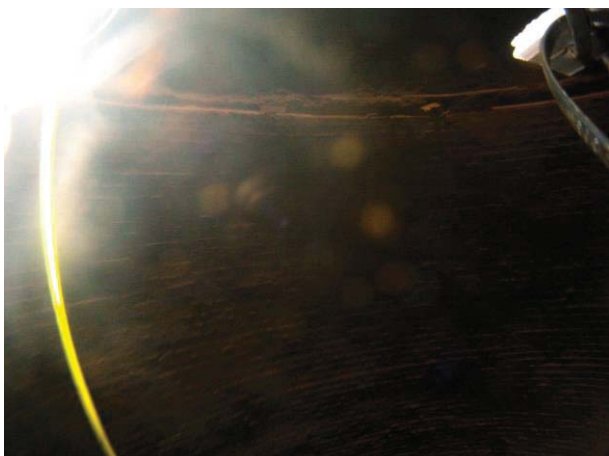
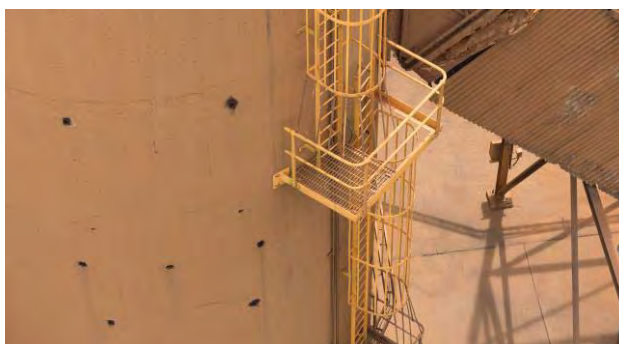
Item: 3
Location: Corbel 2 to Corbel 3
Condition Code: 7
Observation:

- Partial dislodgement of firebrick lining observed, notably around inlet duct.
- Lining sections were identified to be protruding due to dislodgment,
- Cracking of concrete shell is minimal.

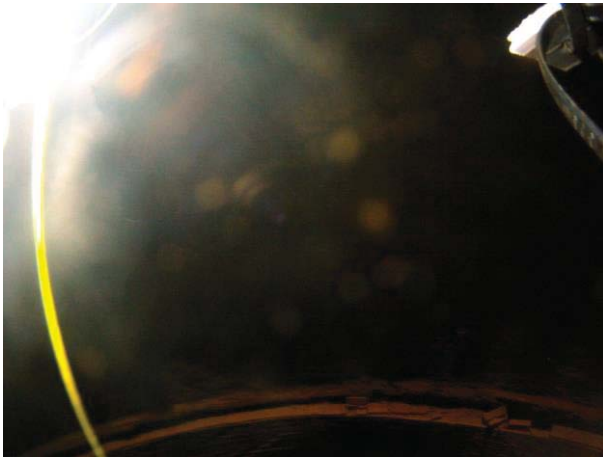
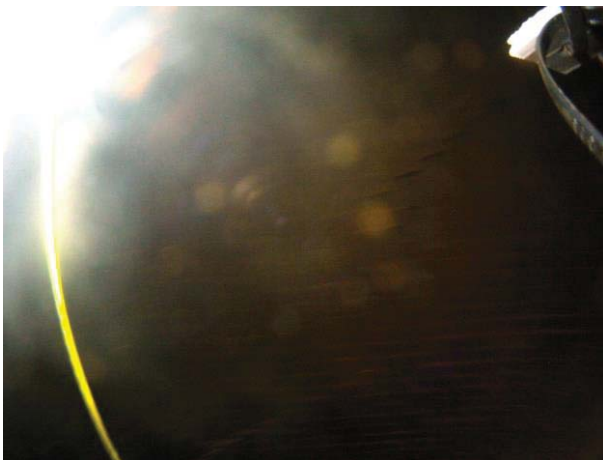
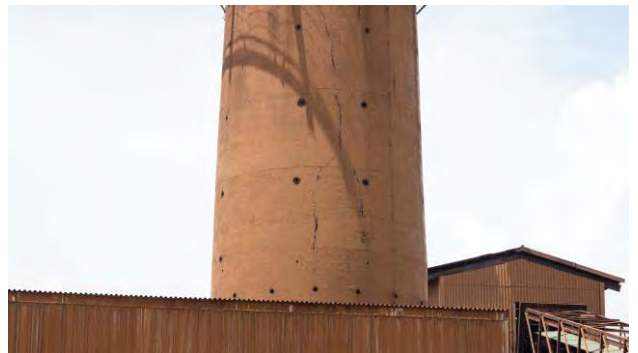
Item: 4

- Partial dislodgement of firebrick lining observed.
- Lining sections were identified to be protruding due to dislodgment.
- Loose fragments identified on Corbel 3.
- Cracking of concrete shell was dominant on southern half, with some seepage of acidic material through the cracks noted.

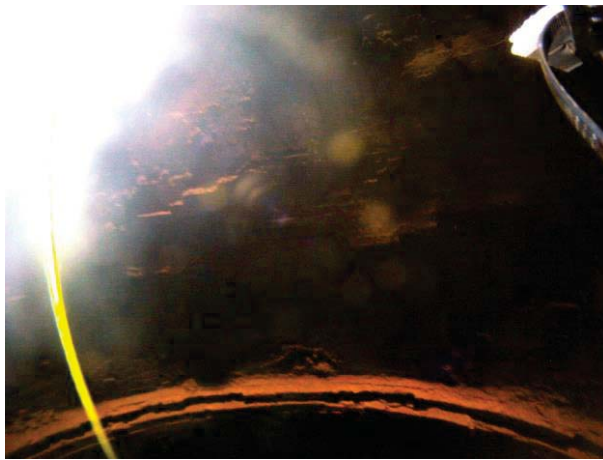
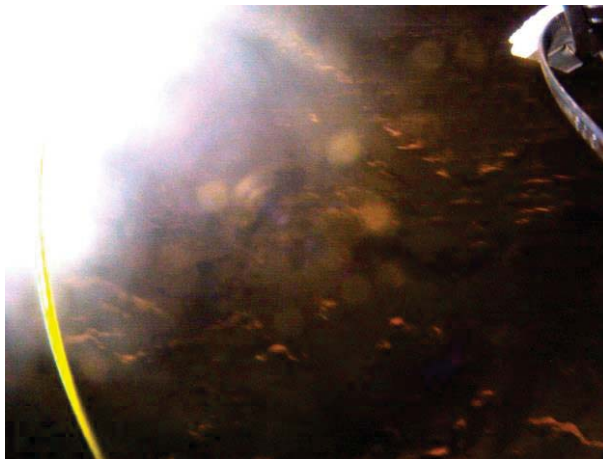
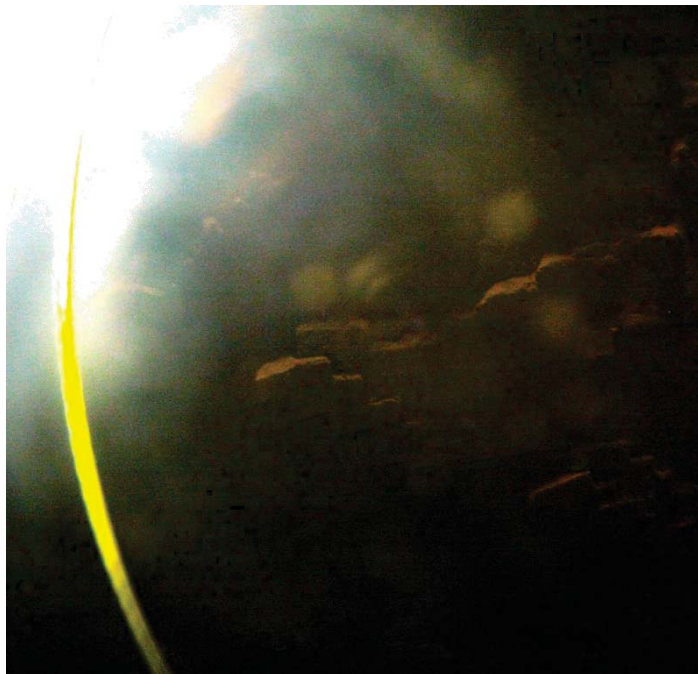
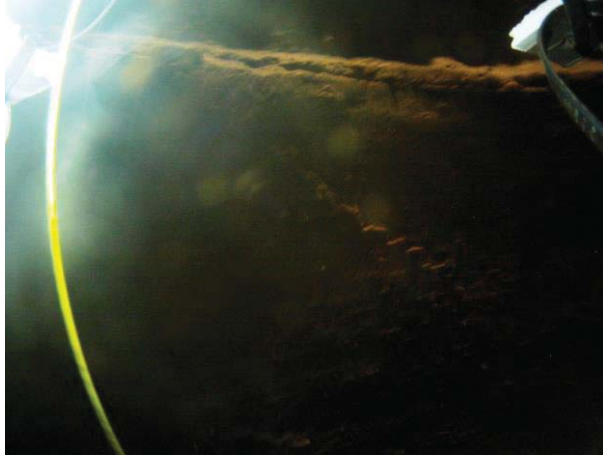
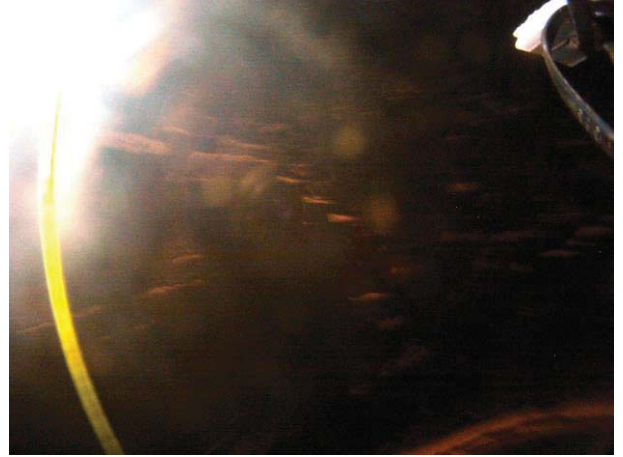
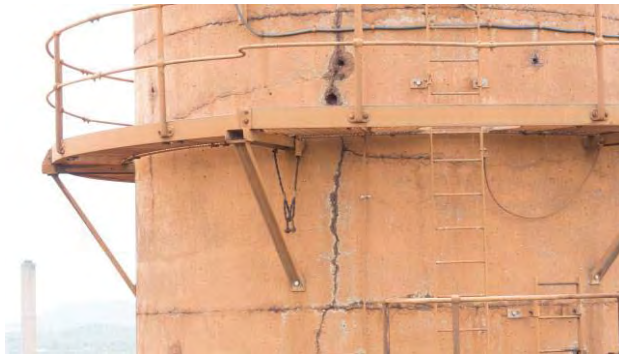
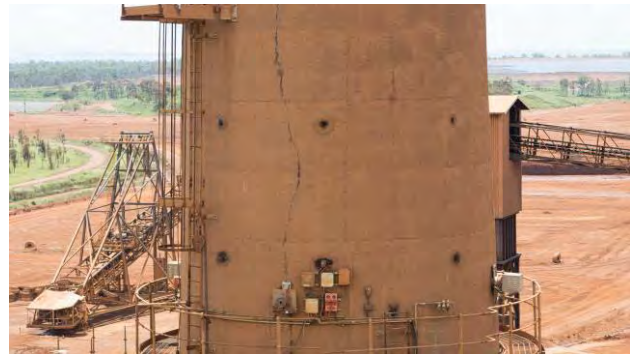
Item: 5
Location: Corbel 4 to Corbel 5
Condition Code: 9
Observation:

- Complete dislodgement of firebrick lining observed, exposing concrete shell to acidic environment.
- Approximately 3% total firebrick lining area is missing from this area of dislodgment.
- Remaining brickwork is loose in locations
- Loose fragments identified on Corbel 4.
- Concentrated locations of acidic material present in fines accumulation, as evident by the “moist” look of fines.
- Cracking of concrete shell was dominant on eastern and western faces, with seepage of acidic material through the cracks noted.

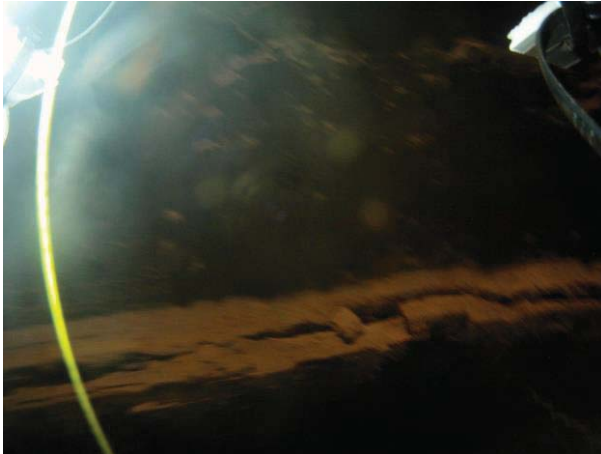
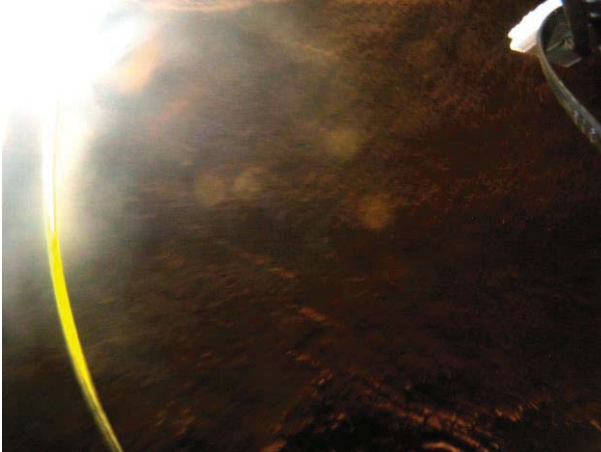
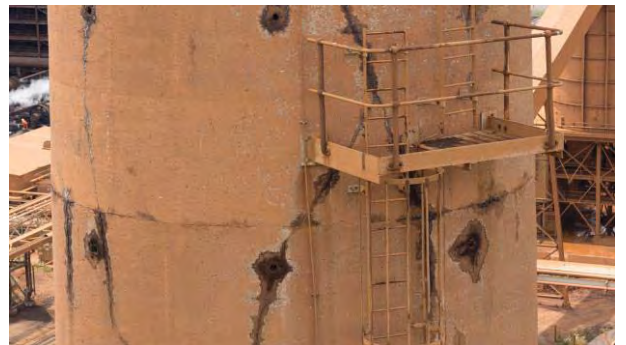
Item: 6
Location: Corbel 5 to Corbel 6
Condition Code: 8
Observation:

- Partial dislodgement of firebrick lining observed, resulting in the protrusion of sections.
- Loose fragments identified on Corbel 5.
- Concentrated locations of acidic material present in fines accumulation, as evident by the “moist” look of fines.
- Cracking of concrete shell was dominant on southern face, although was observed all around with seepage of acidic material through the cracks noted.
