Subject: FW: QN - 16 February - Roaster incident update
Attachments: 2016 02 16 330-1401 Roaster 1 EVD Explosion Post Incident External Damag....pdf

POST-INCIDENT EXTERNAL DAMAGE SURVEY

Equipment No:	330-1401 Roaster 1	Cintellate:	INC-36529
Inspected By:		Inspection Date:	16/02/2016

MAJOR HAZARD FACILITIES AUDIT REPORT

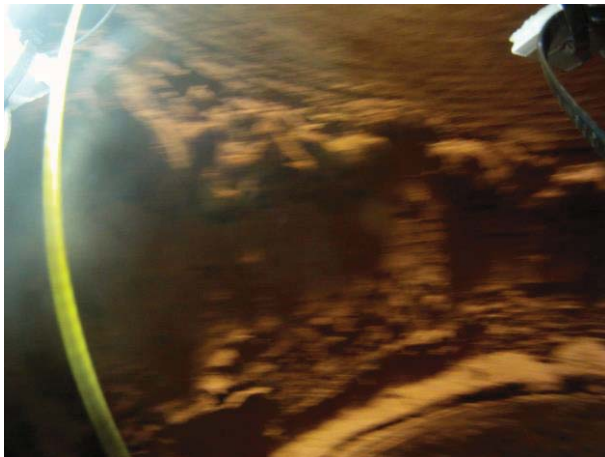
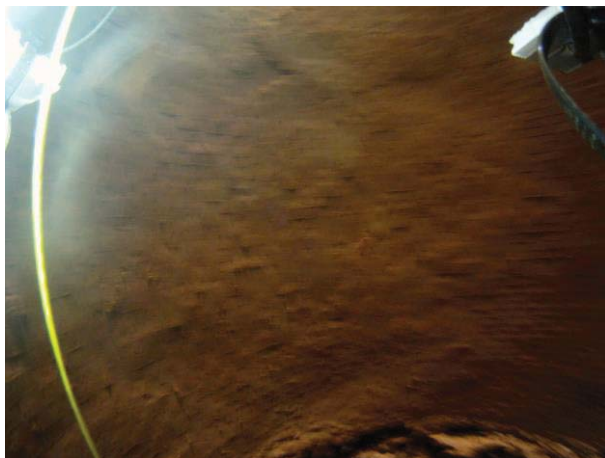
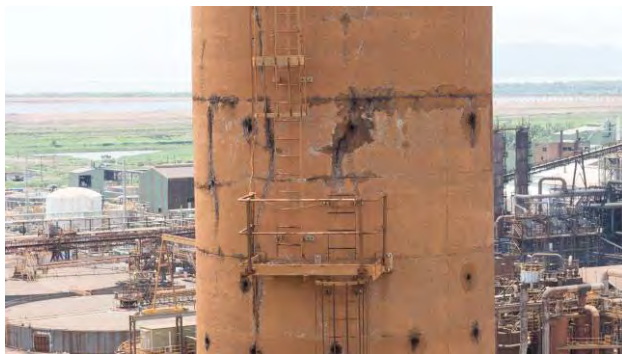
Item: 7
Location: Corbel 6 to Corbel 7
Condition Code: 9
Observation:

- Complete dislodgement of firebrick lining (of approximately 1.5 m height) observed above Corbel 6.
- Dislodged section equates to approximately 1.5% of total firebrick lining missing.
- Large sections of firebrick lining appear to be sagged, likely due to inadequate support as a result of the missing section.
- Cracking of concrete shell was dominant on southern face, although cracks were observed all around with seepage of acidic material through the cracks noted.

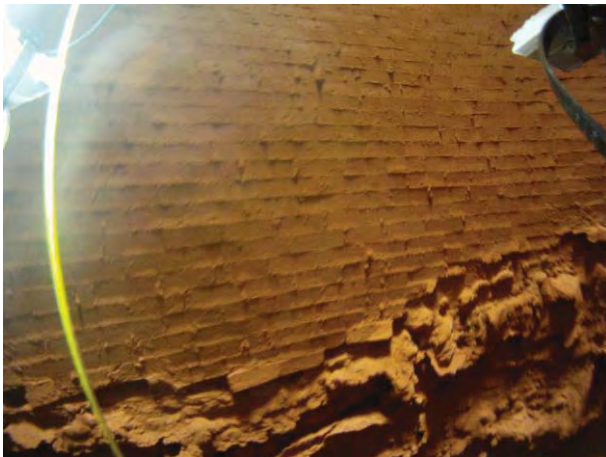
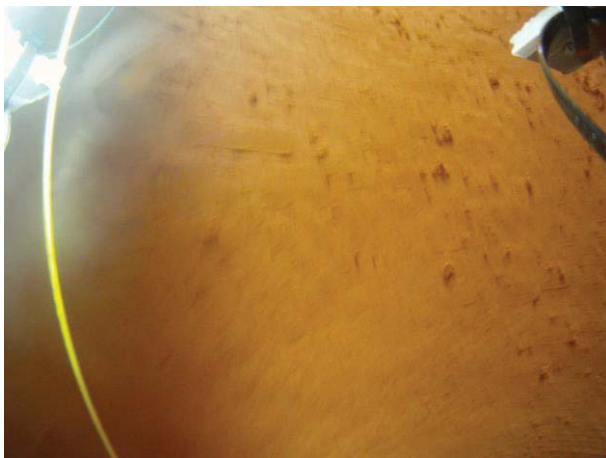
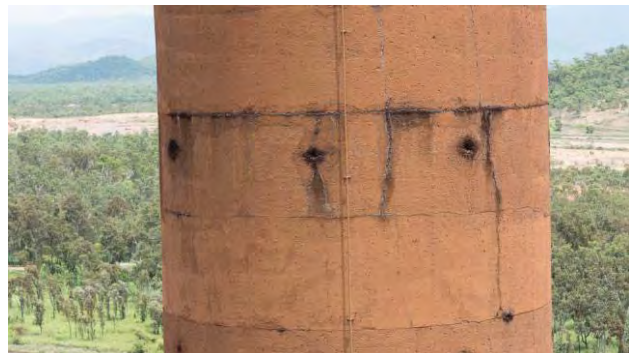
Item: 8
Location: Corbel 7 to Corbel 8
Condition Code: 9
Observation:

- Complete dislodgement of firebrick lining (of approximately 1.5 m height) observed above Corbel 7.
- Dislodged section equates to approximately 1.5% of total firebrick lining missing.
- Large sections of firebrick lining appear to be sagged, likely due to inadequate support as a result of the missing section.
- Cracking of concrete shell was dominant on southern face, although cracks were observed all around with seepage of acidic material through the cracks noted.

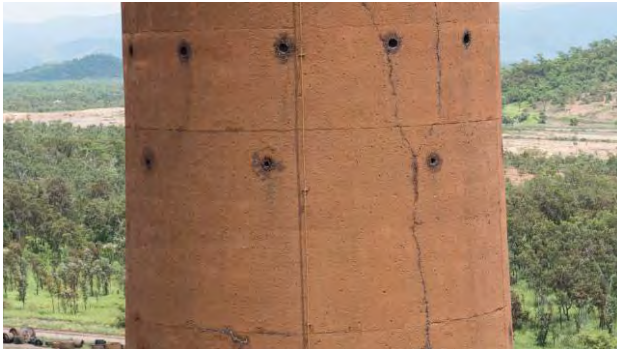
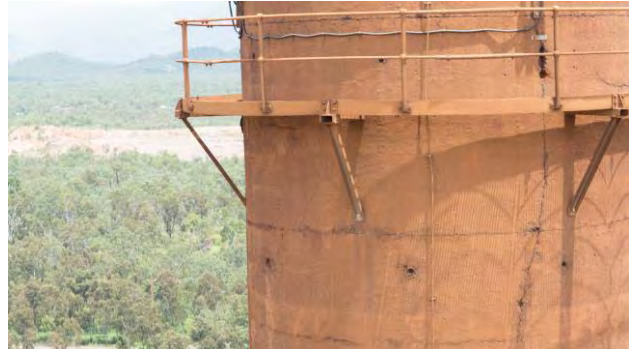
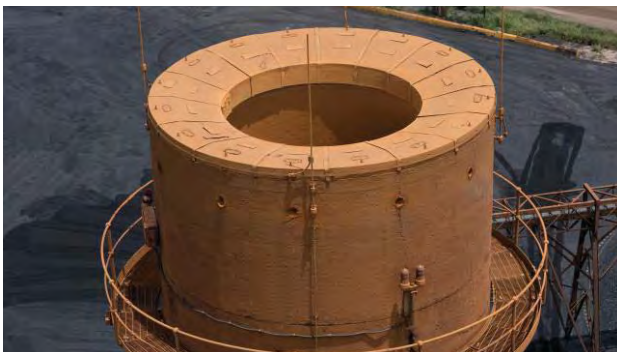
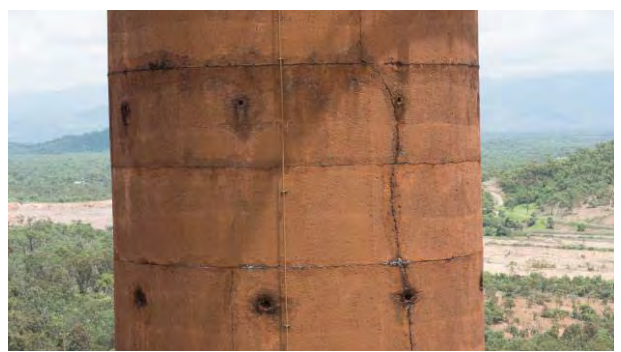
Item: 9
Location: Corbel 8 to Corbel 9 (Top)
Condition Code: Cannot provide
Observation:

- No internal photographs taken for this location.
- Cracking of concrete shell was dominant on southern face, although cracks were observed all around with seepage of acidic material through the cracks noted.

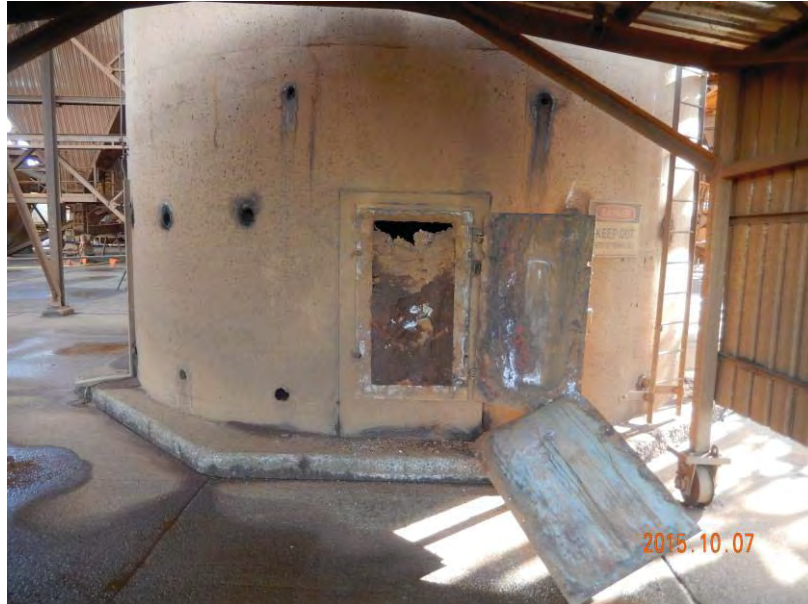
Although discussed in initial meetings with the Area and Planner prior to the inspection, suitable equipment was not used by the Area to remove the debris at the base of the stack, and hence the material was not removed sufficiently. The small attempt at a cleanout was conducted by shovels and rakes. However, due to confined space restrictions and concerns with the brick work lining, this method was not appropriate for the task, or time efficient. In response to the material not being removed to a sufficient degree, the airbag bag intended to be placed at the base of the stack was not installed, as it was determined the remaining space available with the air bag in place would interfere the placement of inspection equipment.

Figure 7: Accumulation of debris at base of stack

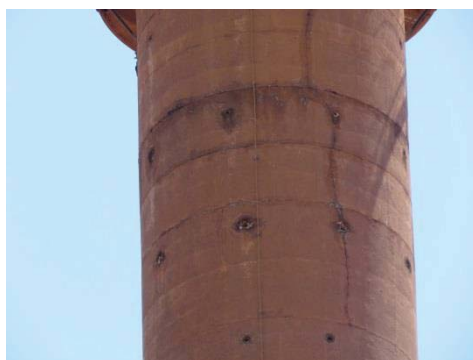
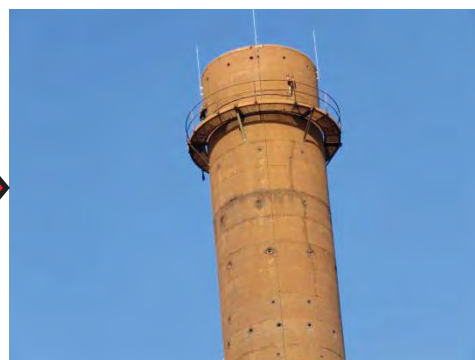
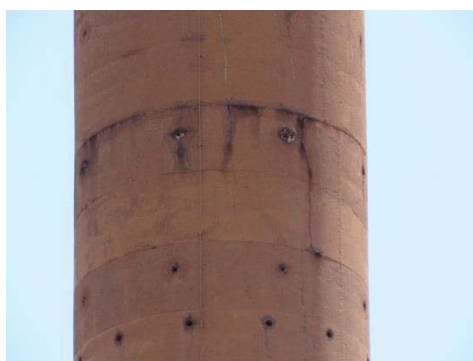
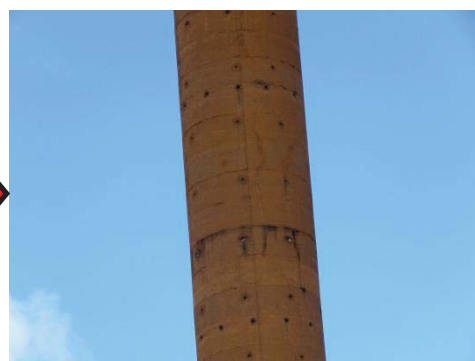
ID	2
Item	Cracks Monitoring – Location 1
Location	Throughout
Finding	No perceptible change in crack length or width in the pre-existing crack network and stack section connections was observed.
Recommendation	It is recommended to continue monitoring the cracks condition and progression on an annual basis.

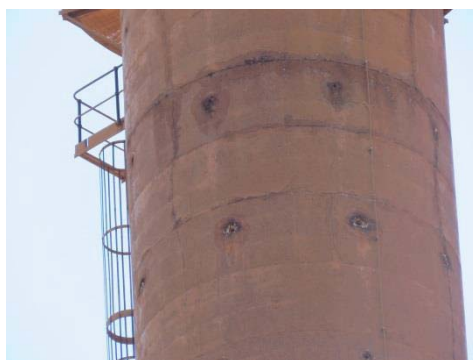
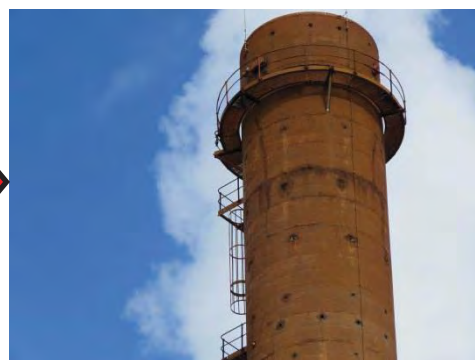
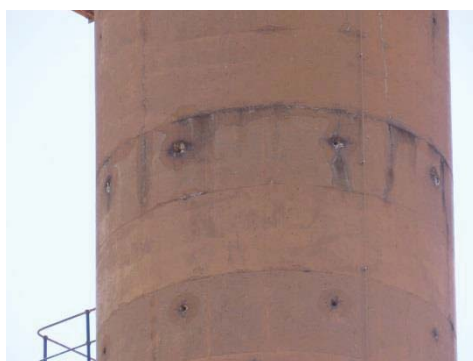
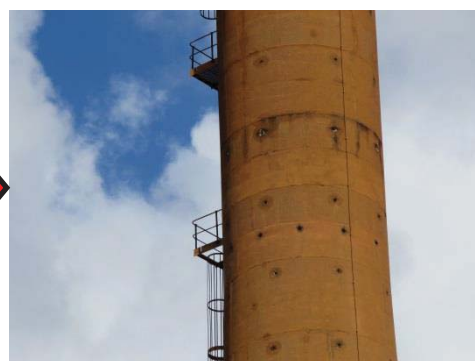
ID	3
Item	Cracks Monitoring – Location 2
Location	Throughout
Finding	No perceptible change in crack length or width in the pre-existing crack network and stack section connections was observed.
Recommendation	It is recommended to continue monitoring the cracks condition and progression on an annual basis.

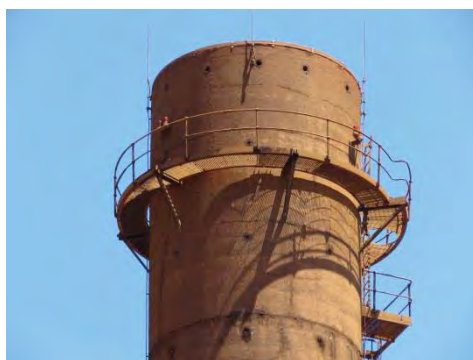
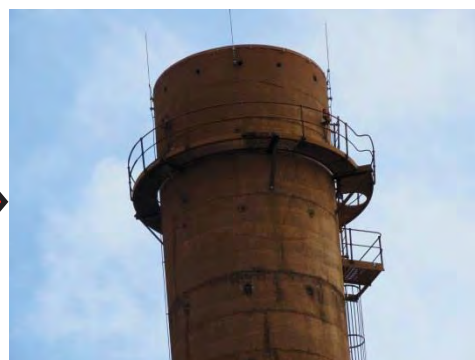
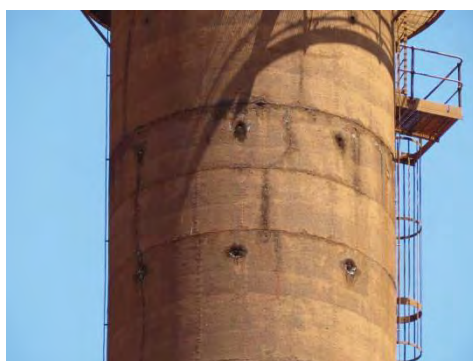
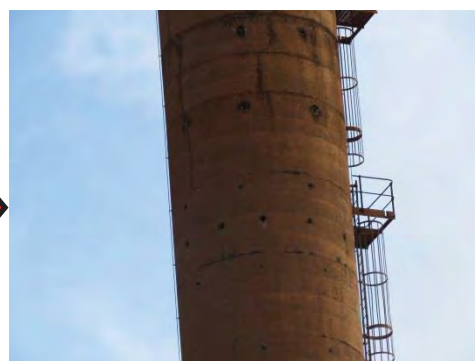
ID	4
Item	Cracks Monitoring – Location 3
Location	Throughout
Finding	No perceptible change in crack length or width in the pre-existing crack network and stack section connections was observed.
Recommendation	It is recommended to continue monitoring the cracks condition and progression on an annual basis.

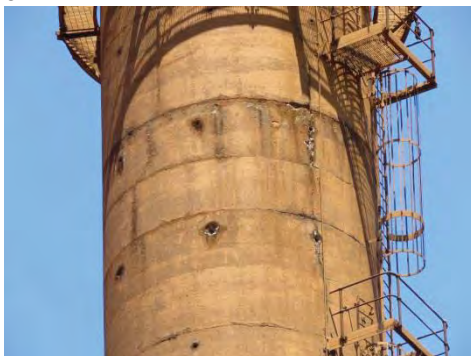
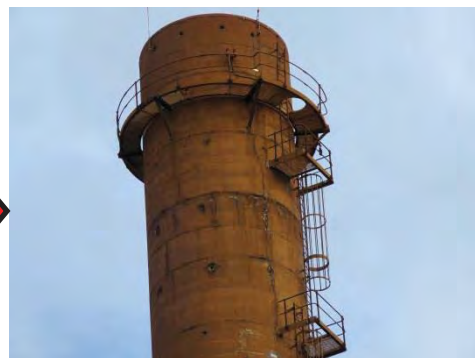
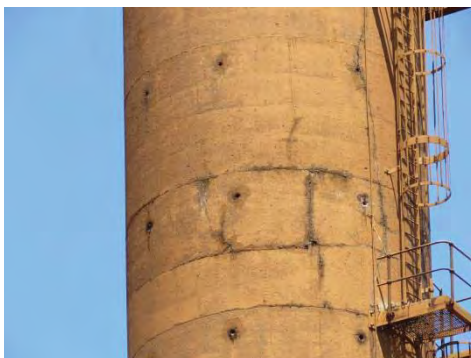
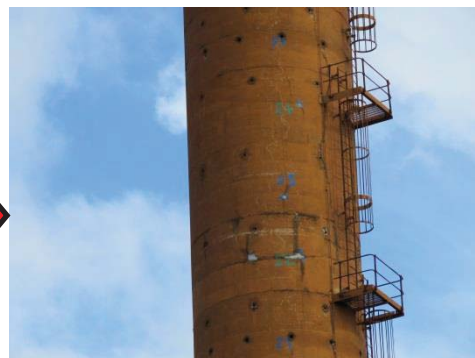
ID	5
Item	Cracks Monitoring – Location 4
Location	Throughout
Finding	No perceptible change in crack length or width in the pre-existing crack network and stack section connections was observed.
Recommendation	It is recommended to continue monitoring the cracks condition and progression on an annual basis.

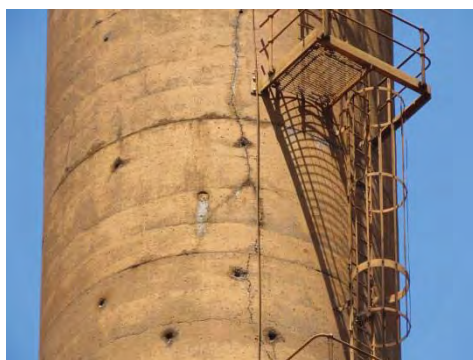
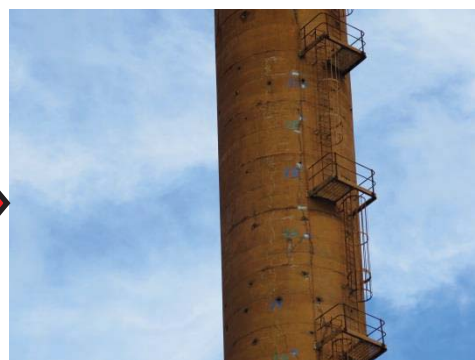
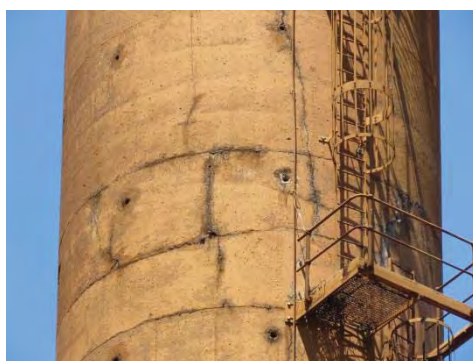
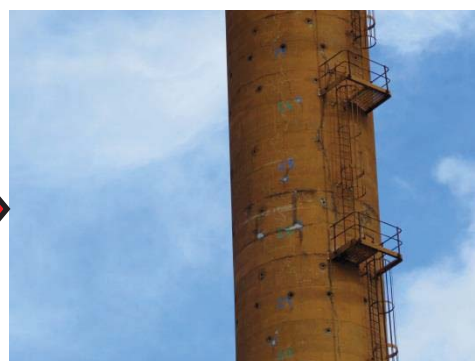
ID	6
Item	Cracks Monitoring – Location 5
Location	Throughout
Finding	No perceptible change in crack length or width in the pre-existing crack network and stack section connections was observed.
Recommendation	It is recommended to continue monitoring the cracks condition and progression on an annual basis.

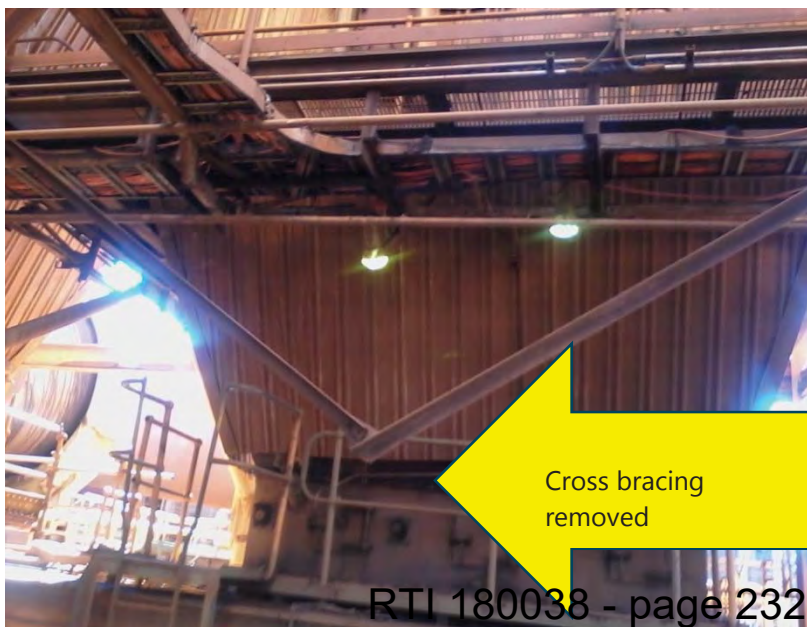
The Ore Drying and Grinding area displayed moderate corrosion levels to the structural steel but extremely severe degradation of the concrete plinths particularly around the Ball Mill area. It was noted that a couple of structural bracing members had been removed to allow access to various equipment. These should be reinstated.

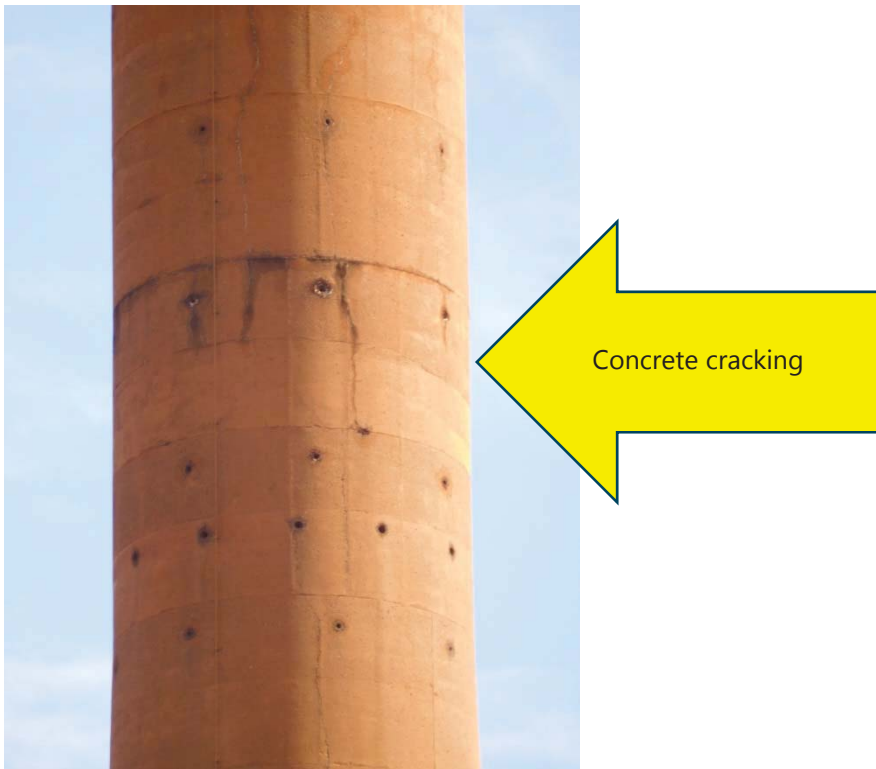
Secondly, the Ore Drying and Grinding area includes the 320-1404 concrete exhaust stack which is the subject of an internal QN Condition Assessment Report. (This report will be addressed later in section 1.2 of this report). Access to the 320-1404 concrete exhaust stack has been restricted and only the external surface could be visually inspected from the ground from a distance of approximately 10 m.

Signs of multiply cracks were evident across the surface of the 320-1404 Concrete Exhaust Stack.

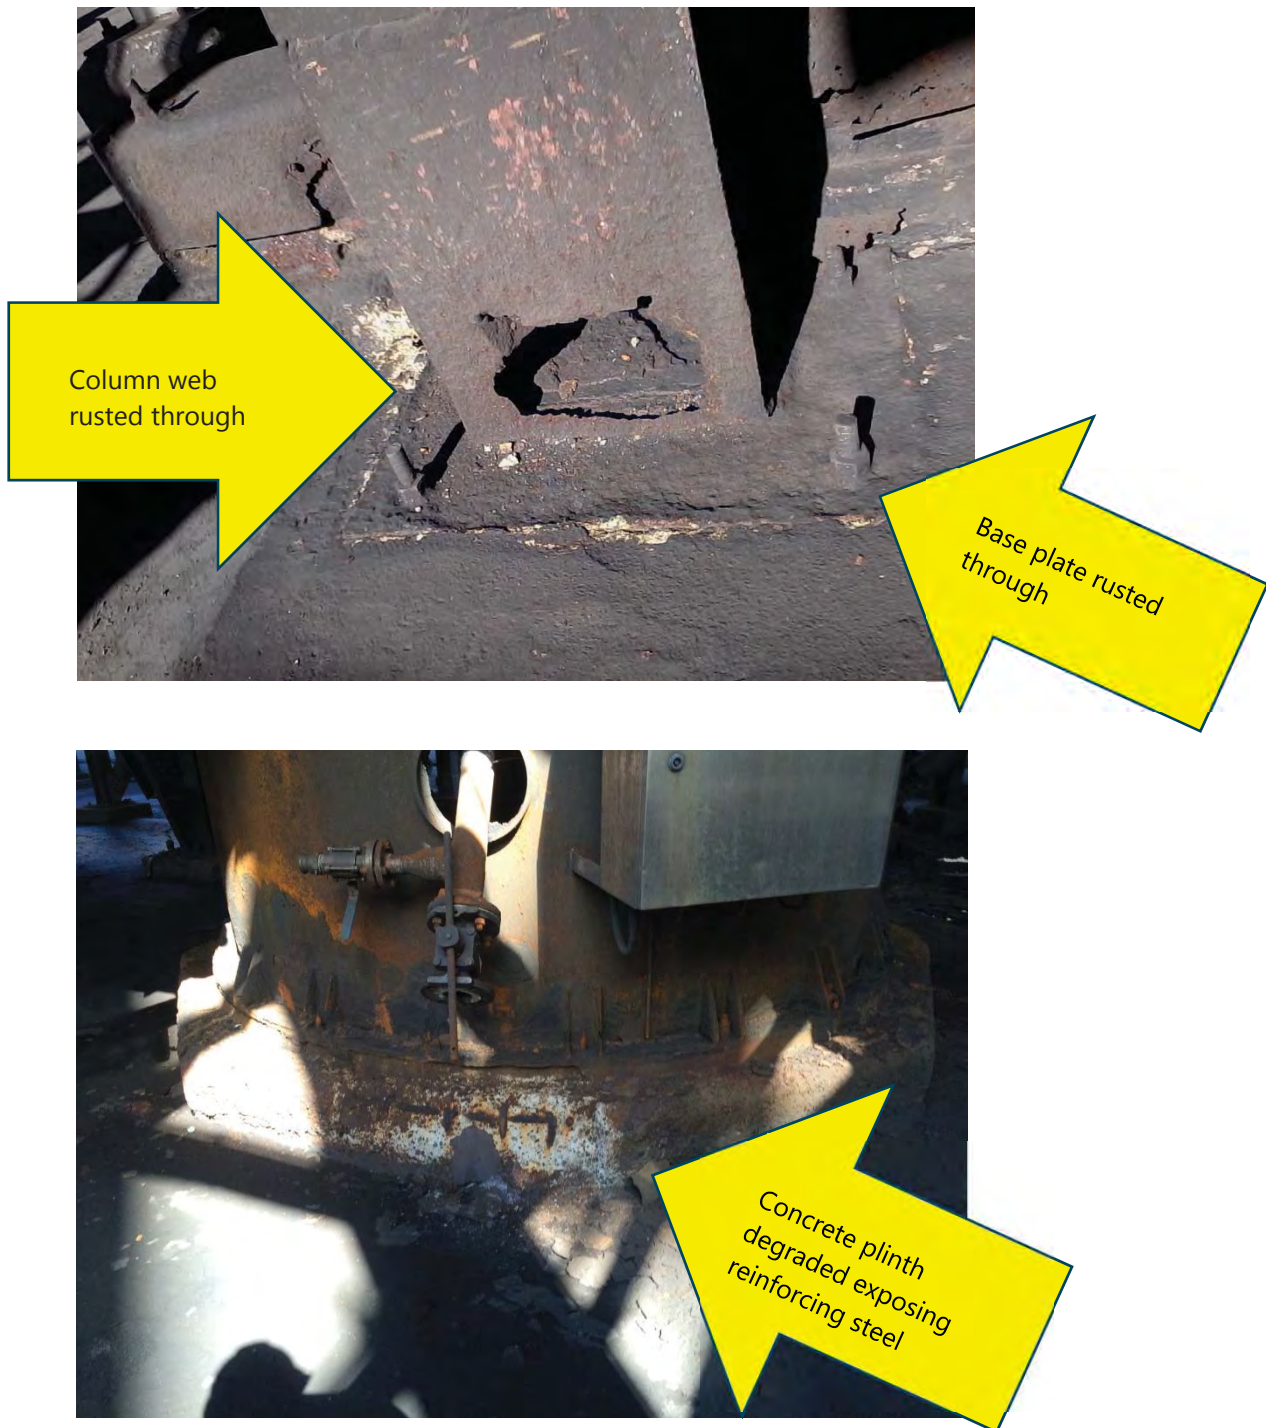
This area also exhibits severe corrosion of the structural steel and severe degradation of the concrete plinths and bunds.

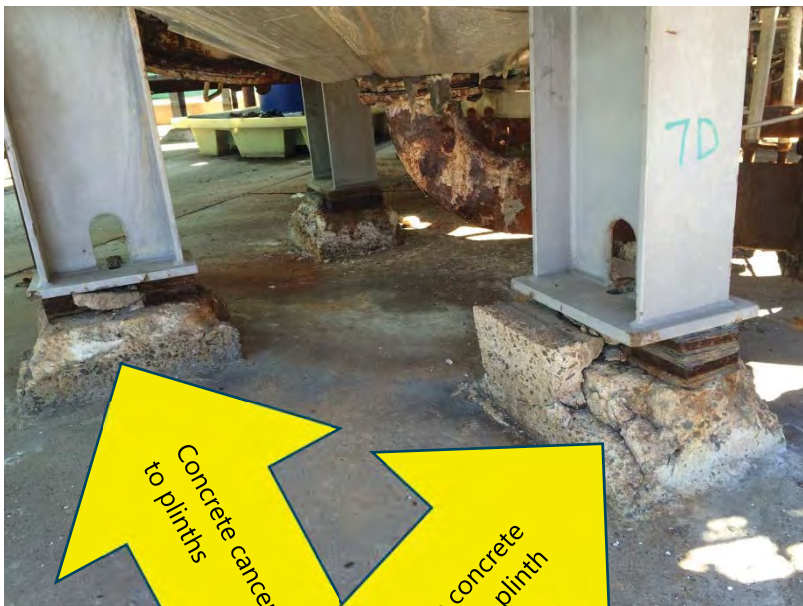
The water purification area also showed signs of severe concrete cancer and high levels of chemical residue build-up over the equipment.

Concrete cancer
to plinths
