# **Findings report:**

# Phase one audits of engineered stone benchtop fabricators in South East Queensland

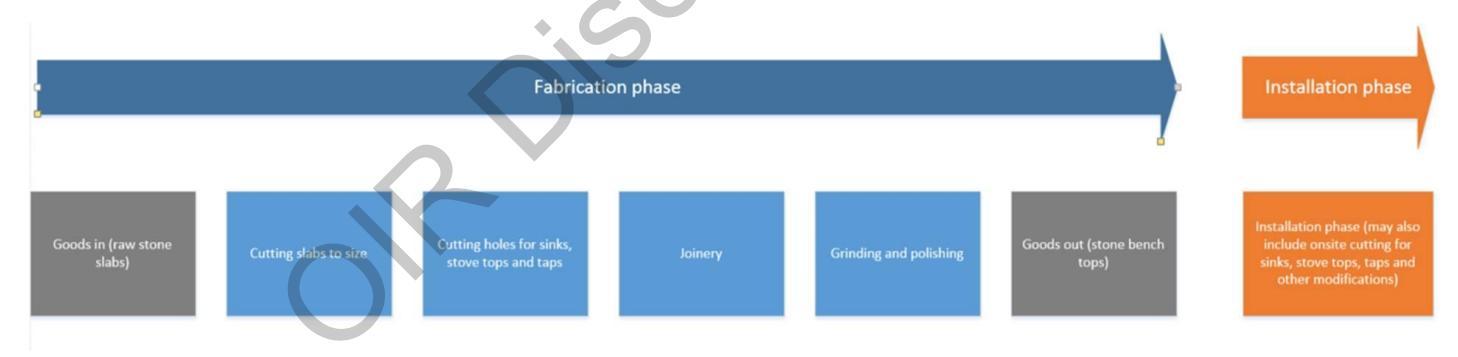
Figure 1 (below) provides a general description of work flow in the stone -benchtop fabrication industry. Each workplace varied slightly depending on work organisation, staff and layout.

Figure 1 - Stone benchtop fabrication and installation process (general)

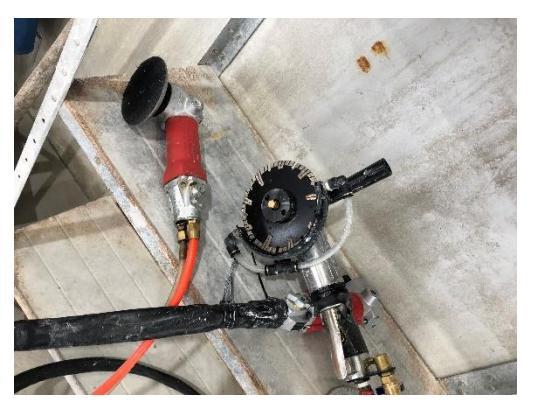
Figure 2 - Photo of a pneumatic polisher and grinder with water feeds.

Water suppression was the primary engineering control used to manage dust at all workplaces visited. Examples of water supressed equipment included water attached bridge saws, water-fed routers, waterjet cutting machines, water supressed polishing machines and water attached grinders and polishers.

Water feeds attached to machinery and hand tools supressed dust to the point where visible dust was not observable. As a consequence of applying water to rotating tools, RCS contaminated water mist was ejected from the process. This mist may have exposed workers by; drying in the air, being of respirable size and breathed in, or depositing on surfaces and later drying, only to becoming airborne again when disturbed.

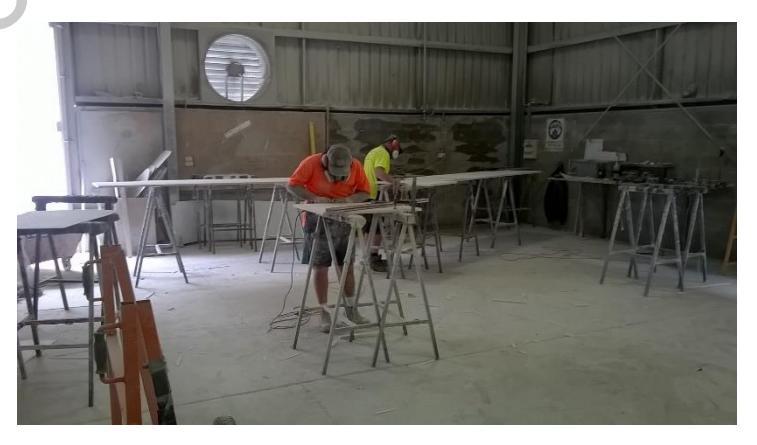
Only one of the ten workplaces conducted dry cutting as a primary process. They complete sink and stovetop cut-outs, dry grinding, edge grinding and bevelling without water suppression or local exhaust ventilation. This was replaced with wet cutting and grinding methods after enforcement action. Five of the ten workplaces self-reported that they used dry cutting previously to fabricate benchtops.

Figure 3 - Photo of two workers conducting dry cutting. Dust is visible on the floor and workers clothing. Enforcement action was taken to prohibit the process until exposure risks were managed. Photo by WHSQ.

None of the workplaces visited sanded or polished stone dry. Dry cutting, grinding and polishing is unnecessary and can be readily substituted for wet methods.

This position is supported by the fact that all workplaces who self-reported previously using dry cutting were able to do the same tasks with wet methods.

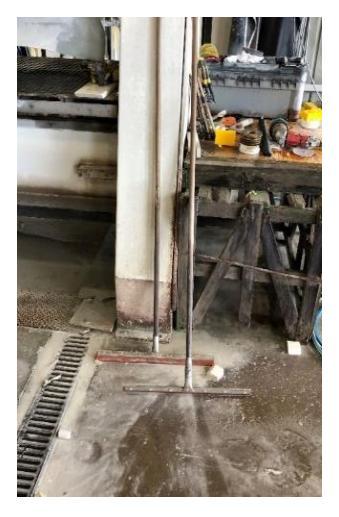
A slurry of stone and water was created by wet processes. All the sites visited had some form of curbing and channelling installed to contain and remove the slurry. In many cases slurry was allowed to dry on the floor and other surfaces leaving deposits of dry stone dust that could be disturbed and made airborne. The use of fans in the workplace for cooling or ventilation was likely to increase the rate in which wet surfaces dried.

Figure 4 - Instead of dry sweeping, squeegees were commonly used to move stone slurry into floor grates. Photo by WHSQ

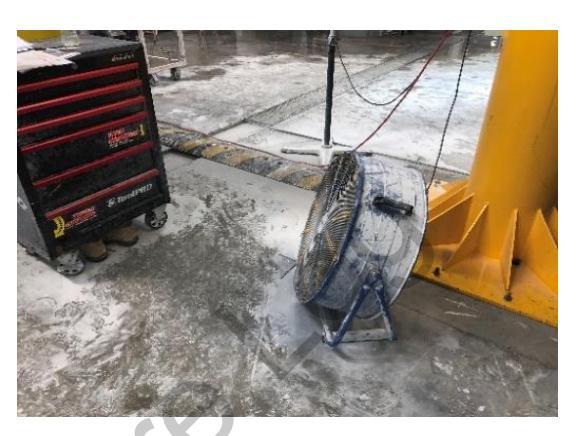
It is likely that this poor housekeeping would increase the level of airborne RCS within the workplace and contribute to the exposure levels of all fabrication workers. Poor cleaning methods included the use of compressed air, dry sweeping or high pressure water. Poor cleaning may have generated airborne dust causing exposure.

Figure 5 - Photo of dust deposits allowed to dry. Fans may have assisted in drying wet surfaces leaving dry stone deposits.

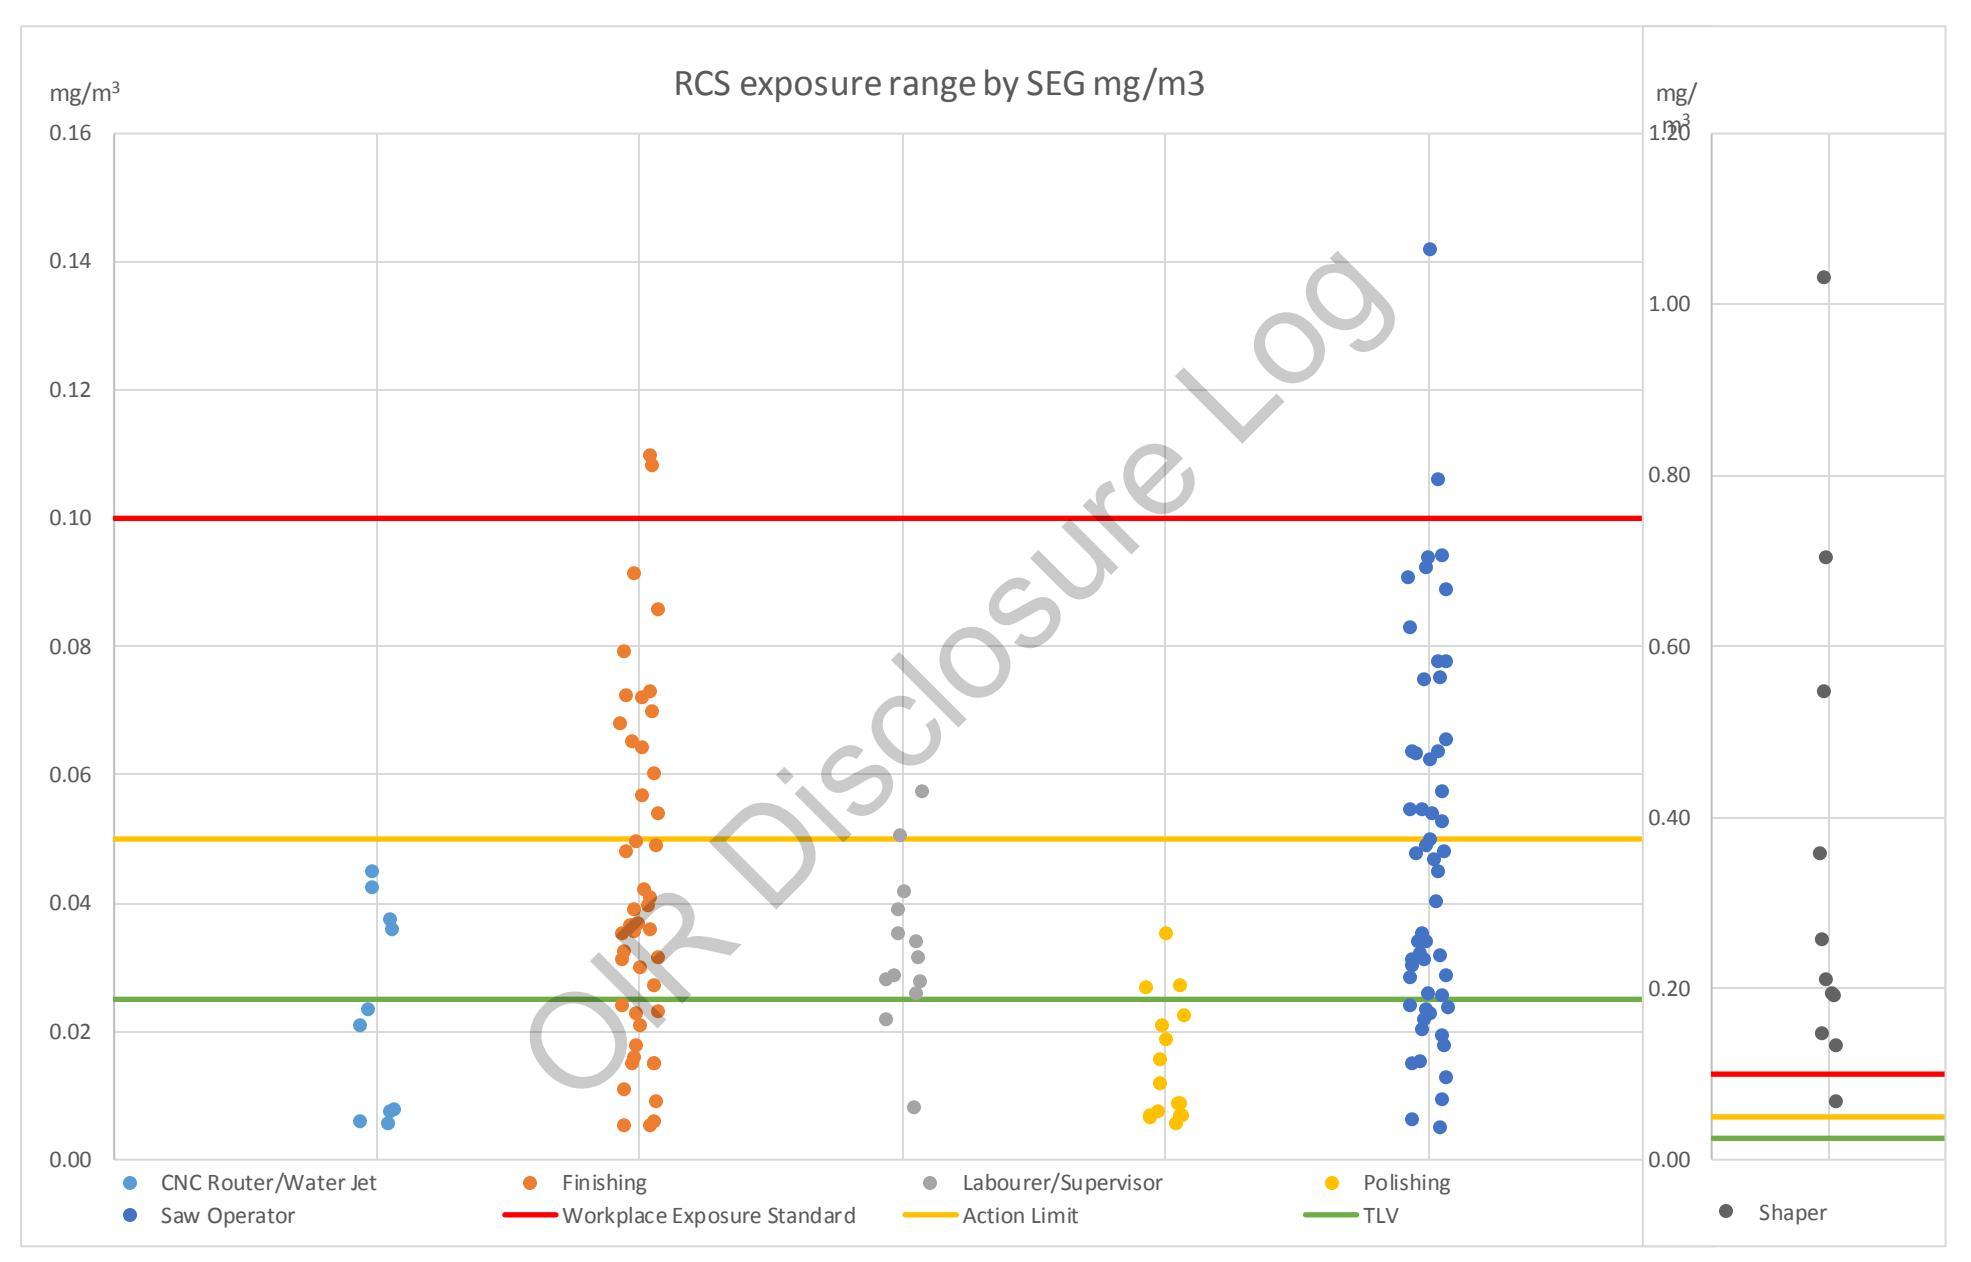
Ten individual measured concentrations exceeded the WES for the Shapers SEG, compared with four for every other SEG combined (two in Finishing, two in Saw operators).

The majority of individual measured concentrations for the CNC Router/Water Jet operators, Labourer and Supervisor and Polishing SEGs are below the orange line (action level).

Figure 6 - Graph of individual exposures (8hr TWA) for each SEG

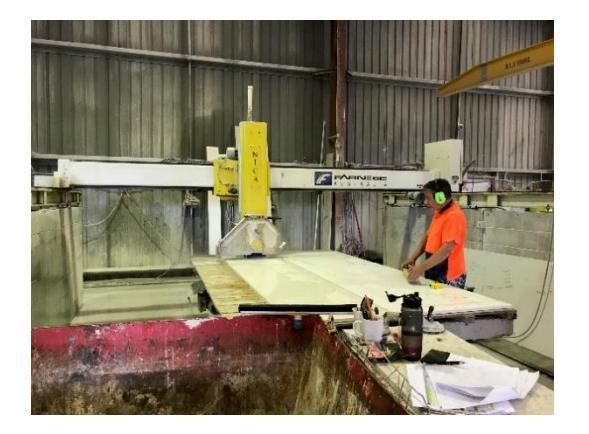
- the speed of operation, size and RPM of the blade
- the design of guarding and how well it contained water mist
- the operators positioning in relation to the process
- whether enough water was supplied for the saw speed both in terms of flow rate and volume.

Figure 7- Older manual bridge saws without any means to prevent workers from standing close to the process when operating the saw. Photo by WHSQ.

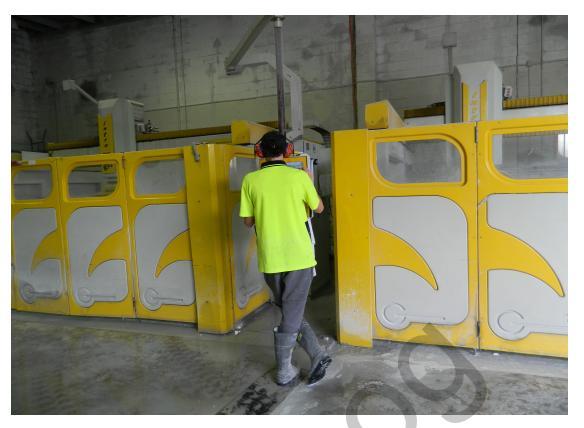
Figure 8 – Newer CNC bridge saws were fitted with bay doors. Photo by WHSQ.

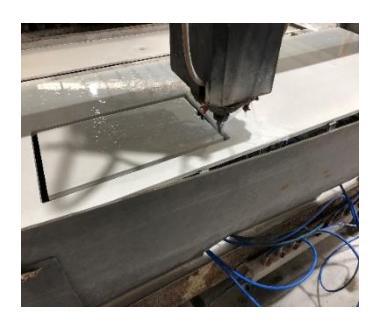
Figure 9 - CNC router without plastic shrouding to contain dust and water mist. Photo by WHSQ.

- containing or capturing water mist using plastic shrouds, flaps or brush guards around the tool (refer to Figure 9 and 10)
- isolating the worker from the process either through physical barriers like bay doors or through distance
- maintaining water control systems to ensure an adequate flow of water during cutting
- preventing water drying on surfaces.

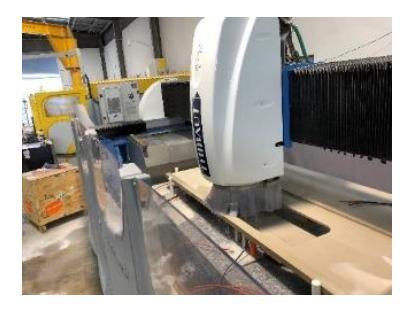
Figure 10 - CNC router with plastic shrouding. Photo by WHSQ.
